**QAL'EH-I YAZDIGIRD**  
**An Overview of the Monumental Architecture**

**BY**  
**EDWARD J. KEALL**

*Reprinted from*  
**IRAN XX 1982**

*Published by*  
**THE BRITISH INSTITUTE OF PERSIAN STUDIES**

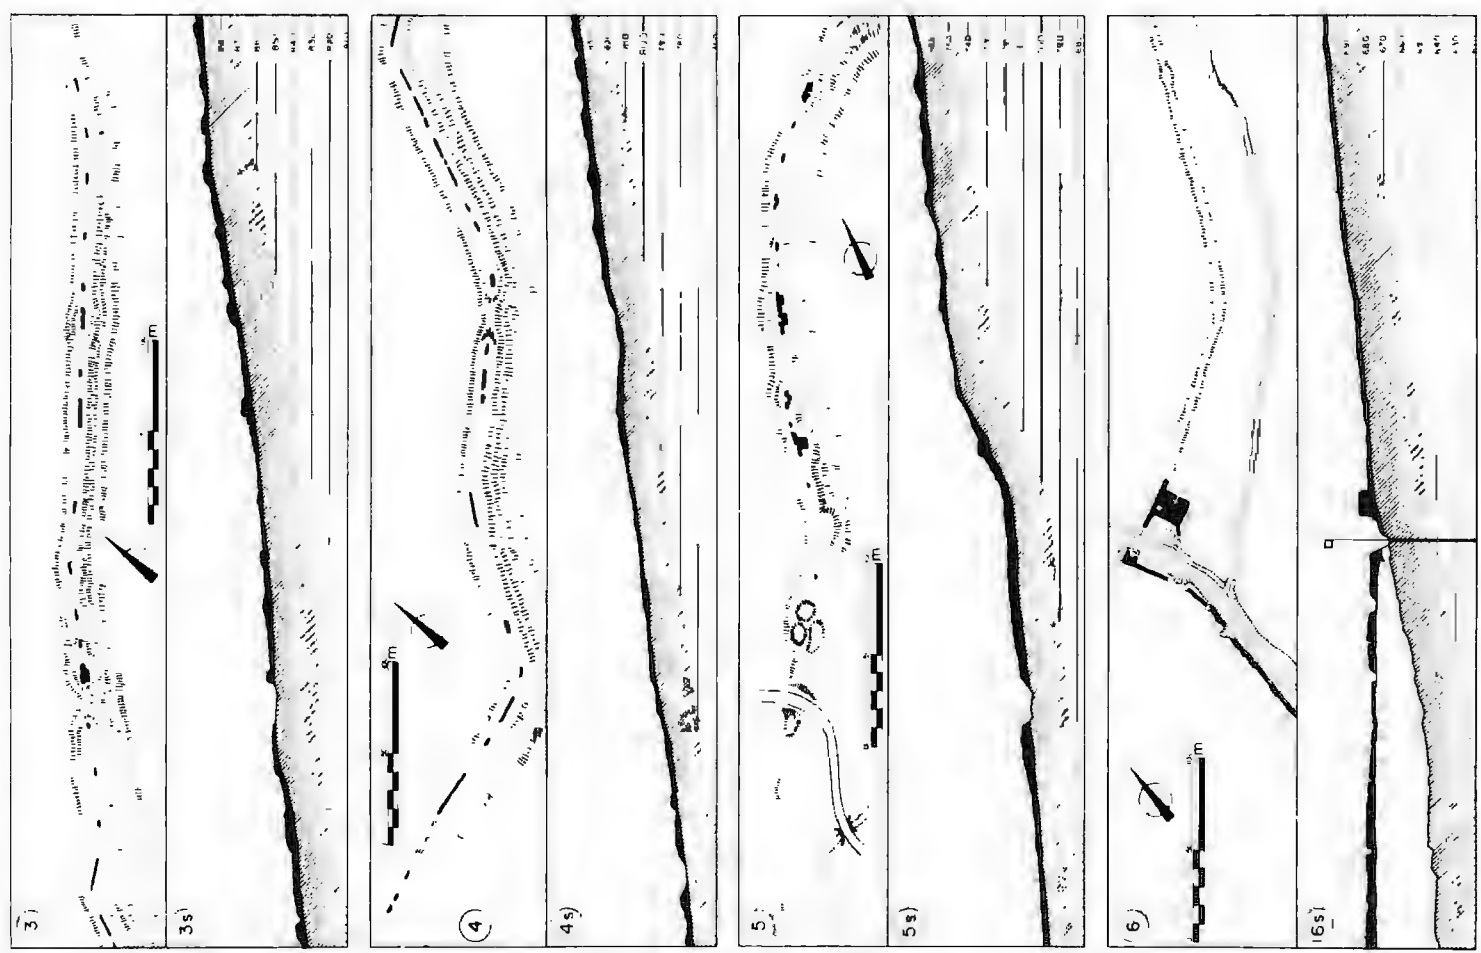
Fig. 2b. Plans and elevations of four lengths of the main defensive wall (Zendan to Ashpaz Gah), based on surface remains.

- <sup>5</sup> Free-standing towers are seen in Pl. Ic; evidence of a guard chamber is shown in Pl. 11c; and the extant remains of the wall are indicated in Figs. 2a and 2b.

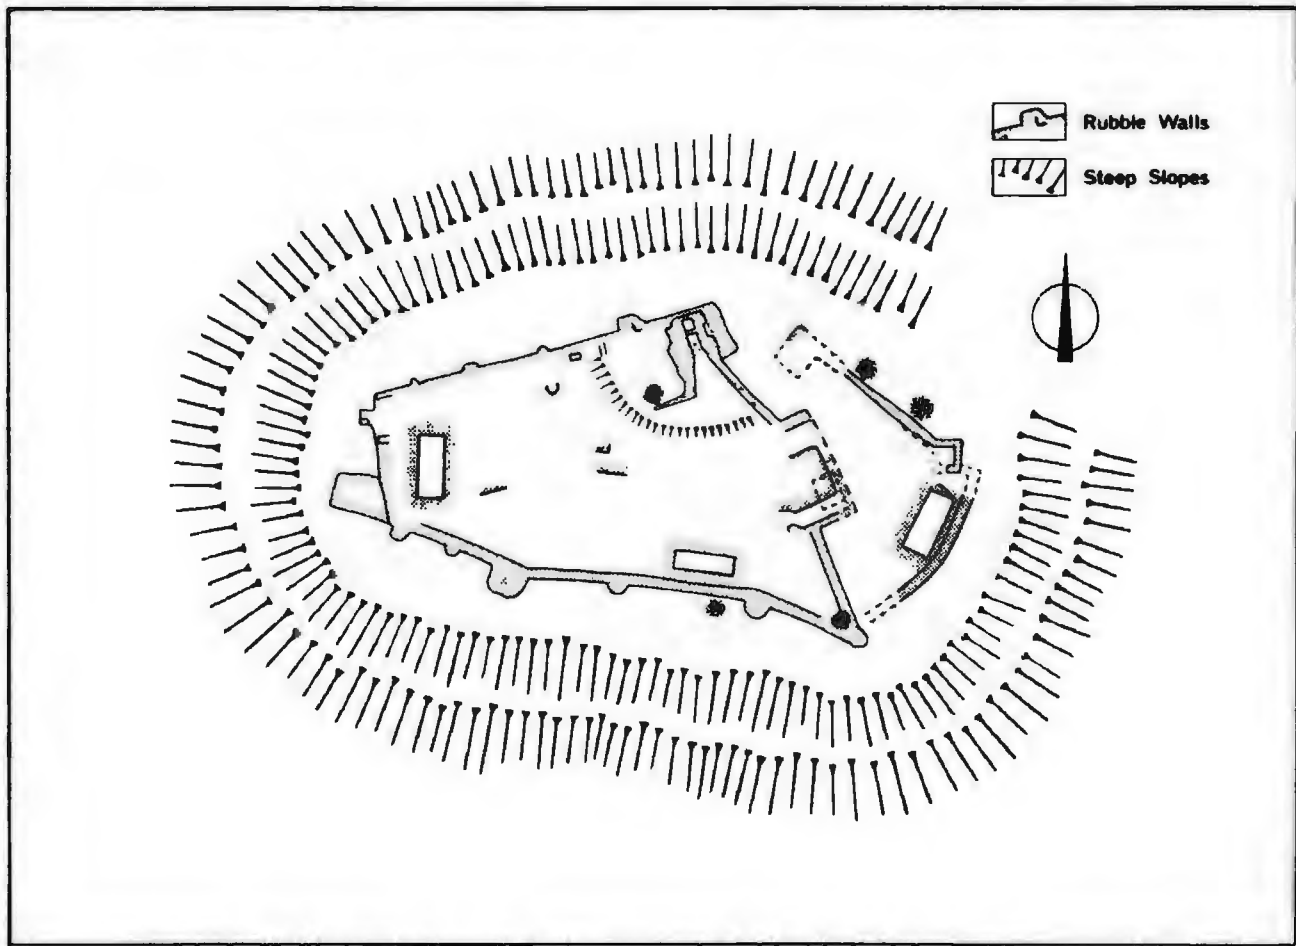
Fig. 5. Plan of the Upper Castle (Qal'eh-i Yazdigird), based on surface remains.

garrison above. Although the castle's later modifications obscure the picture, the original structure can be seen to have had a projecting wall which acted as a protective device for the entranceway (Fig. 5). Small divisions on the inside of this protecting wall are perhaps the remains of stalls for animals; however, it is pure speculation as to whether that was indeed their use.

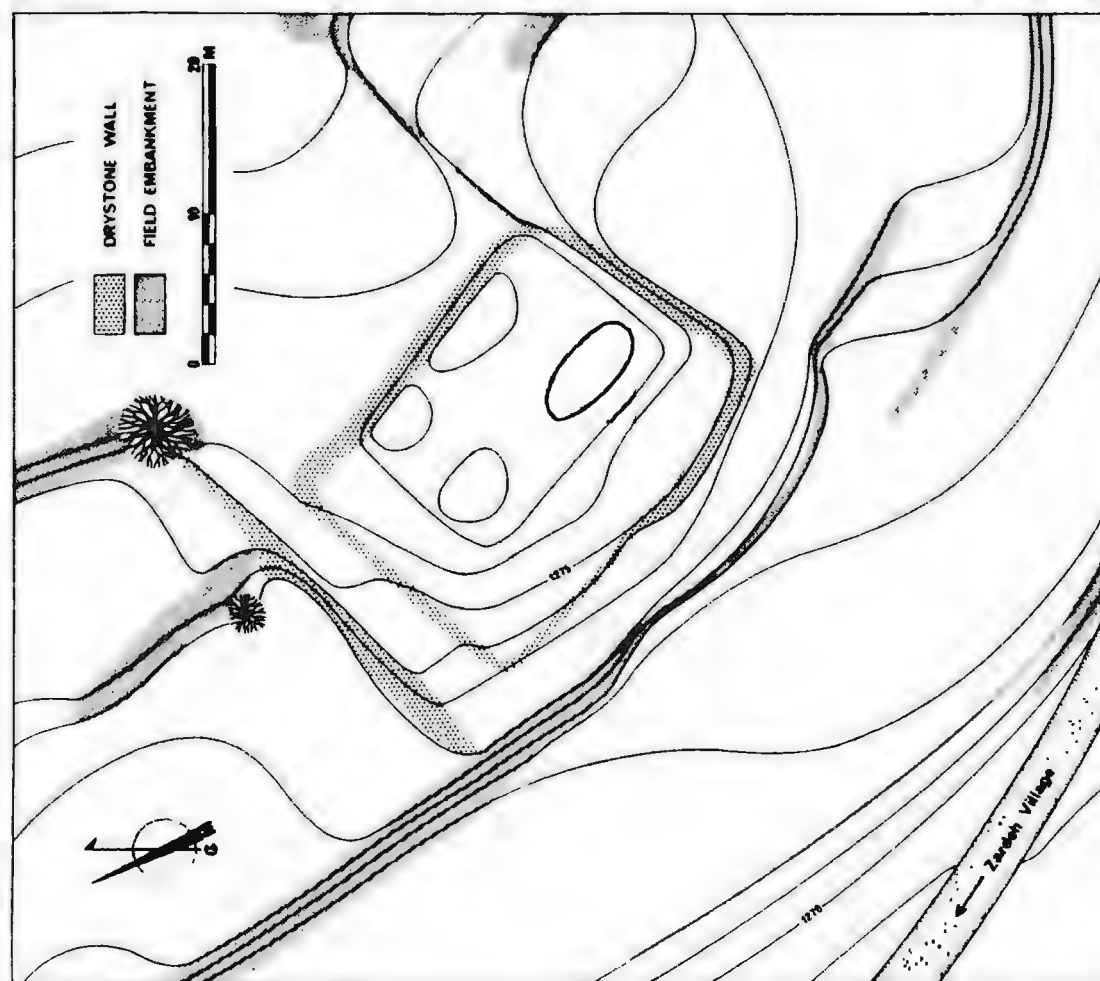
Fig. 7. Plan of Kala Dawar site before excavations.

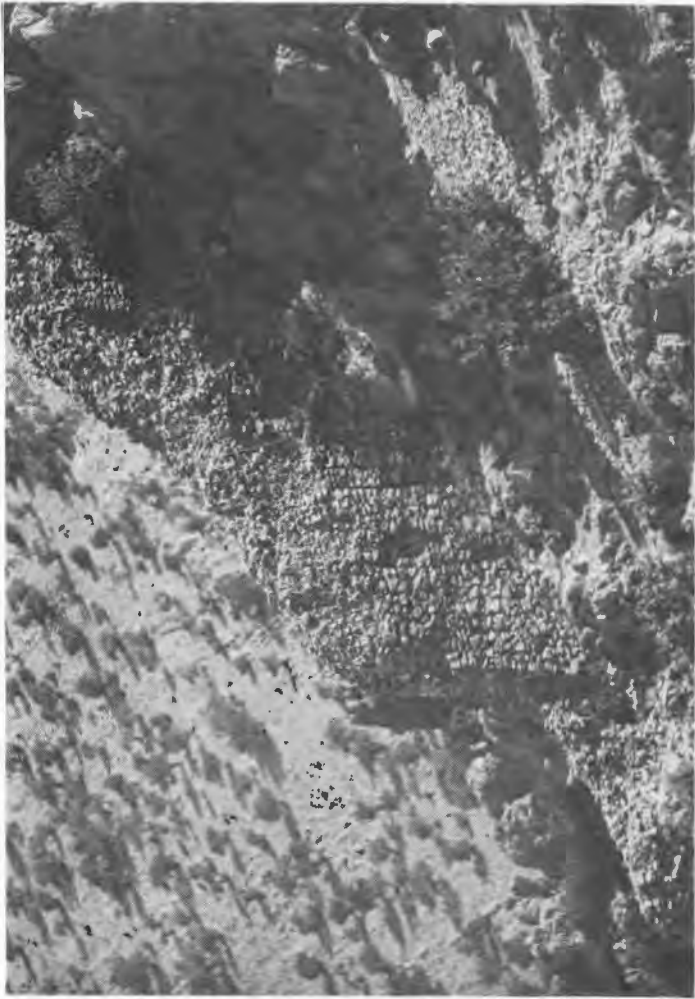
*Pl. 1d. Detail of masonry, showing vertical construction separations, in the main defensive wall on the cliffs below the Upper Castle.*

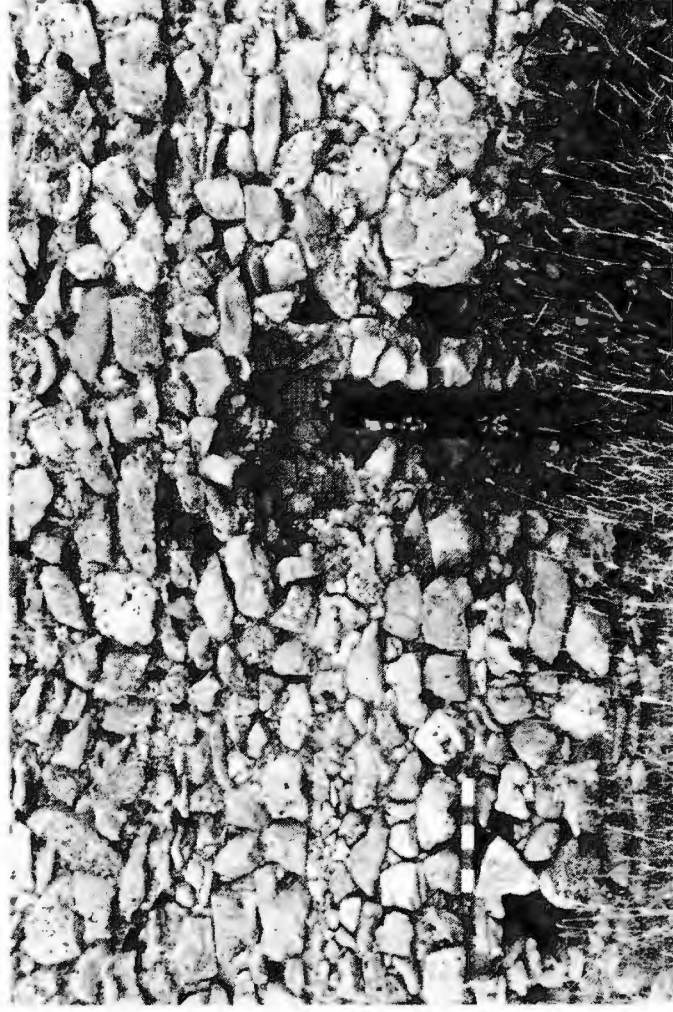
*Pl. II d. Detail of masonry showing four separate "lifts" and an embrasure in the escarpment defensive wall (Ash Rah).*

A distinctive feature of all these rubble walls is that, depending upon the state of erosion, a definite line is discernible in the masonry at certain horizontal intervals (Pls. 11d, 111c). The walls were clearly constructed in "lifts", in the manner of pisé mud walling. A 30-50 cm. height of masonry was laid along a given length of wall. When this had dried sufficiently not to slump, it became the base for the construction of the next course or lift. In this way, with quick-drying mortar, rubble masonry could be laid without the need for formwork. (In some of the embrasures, the mortar on the sides of the opening has obviously slumped, reinforcing the notion that the masonry was laid free-standing). The top of each lift was finished off with a rough layer of mortar, and it is this line which is visible on the eroded face of the Parthian walls. The same principle is used by the modern builders in the area when they lay a band of mud mortar on top of their fieldstone courses. In the case of the section of wall that ascends the cliff below the Upper Castle, vertical divisions are also seen (Pl. 1d). Unfortunately, once again, variations from the norm cannot be used automatically, in isolation from other

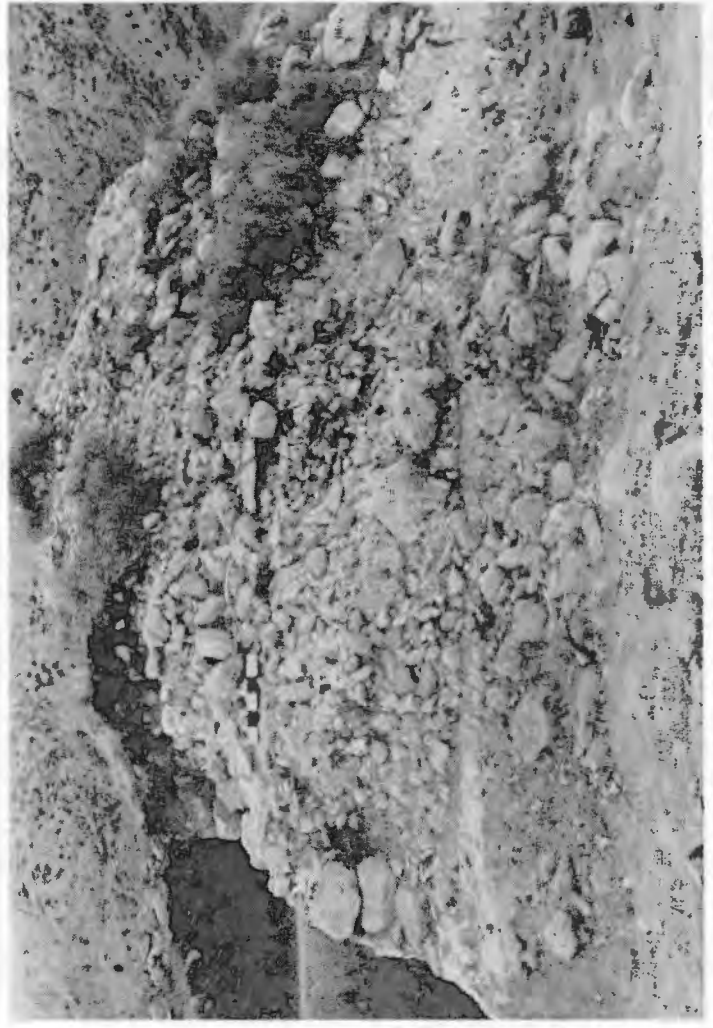
*Pl. IIIc. Section through Zendan defensive wall immediately south of tower WF-1.*

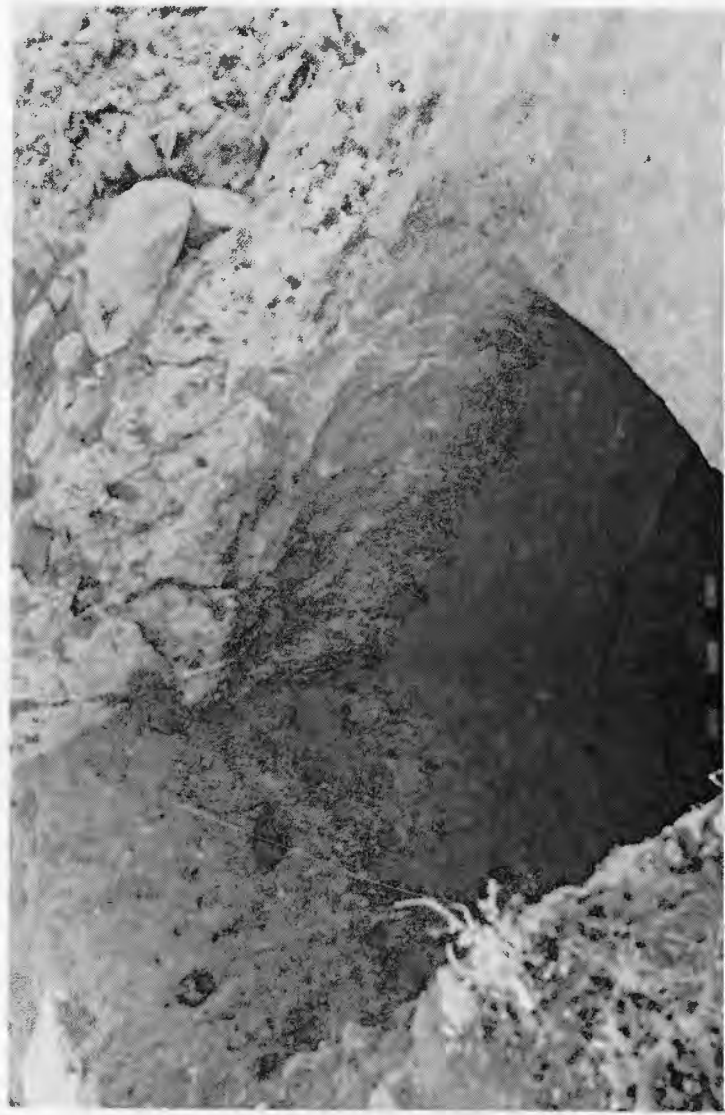
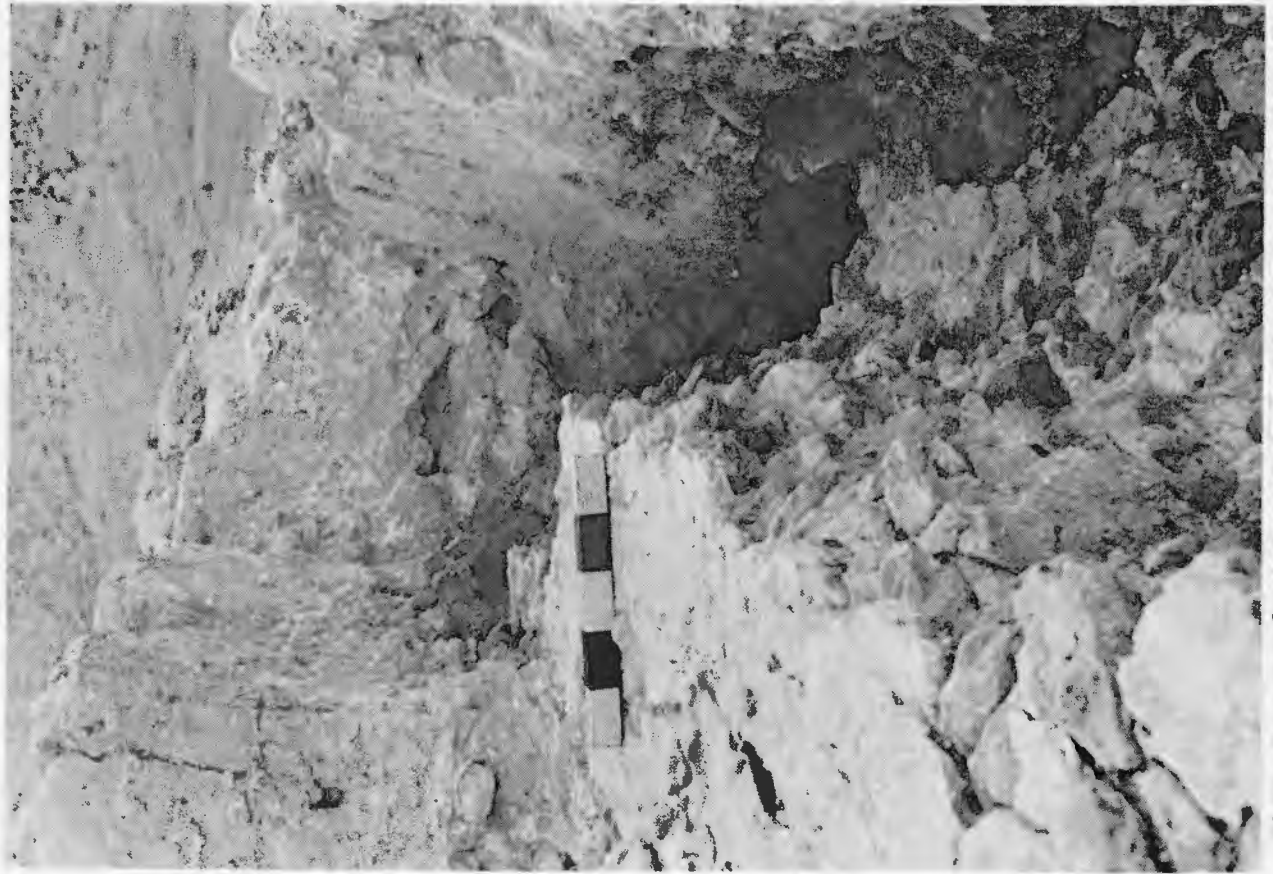
Pl. IVa. Separation of projecting wall of tower WF-1 from the masonry of the wall itself, as seen within the tower chamber.

With respect to the WF stretch of the wall, a further observation can be made about the way in which the masonry of tower WF-1 was laid. It is clear that parts of the curtain wall and the tower were built separately in terms of the actual construction of the masonry. This was not a matter of a later addition, but simply the accretive process of building. The same principle of piecemeal construction has been observed by the author in the foundation walls of the late Parthian fortress at Nippur. There, heavy walls (albeit in mud brick) are made up from segments that interlock on a three-dimensional basis; sometimes the bond occurs horizontally, sometimes vertically. This method would, of course, permit separate gangs of workmen to work independently. In addition, the technique of piecemeal construction may have been used to discourage slumping, since minor settling of the various parts could occur without danger to the whole. Unfortunately, in the case of tower WF-1 at Qal'eh-i Yazdigird, the principle was not put into effect very well. There was a serious slump which is reflected in the way that the masonry of the projecting part of the tower can be seen to have torn away from the masonry of the wall itself (Pl. IVa). The damage does not seem to have been the result of deliberate undermining. Apparently the slump occurred during construction, before the core of masonry was properly cured.

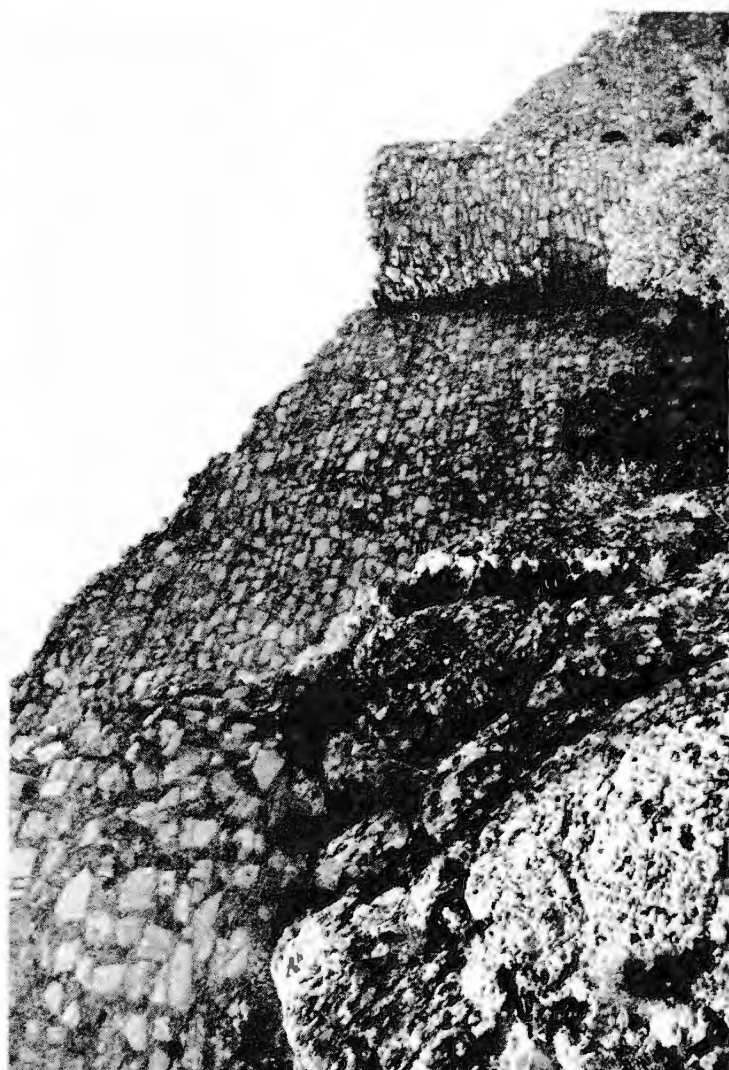
*Pl. V'ic. The north wall face of the Upper Castle showing three "lifts" in the masonry*

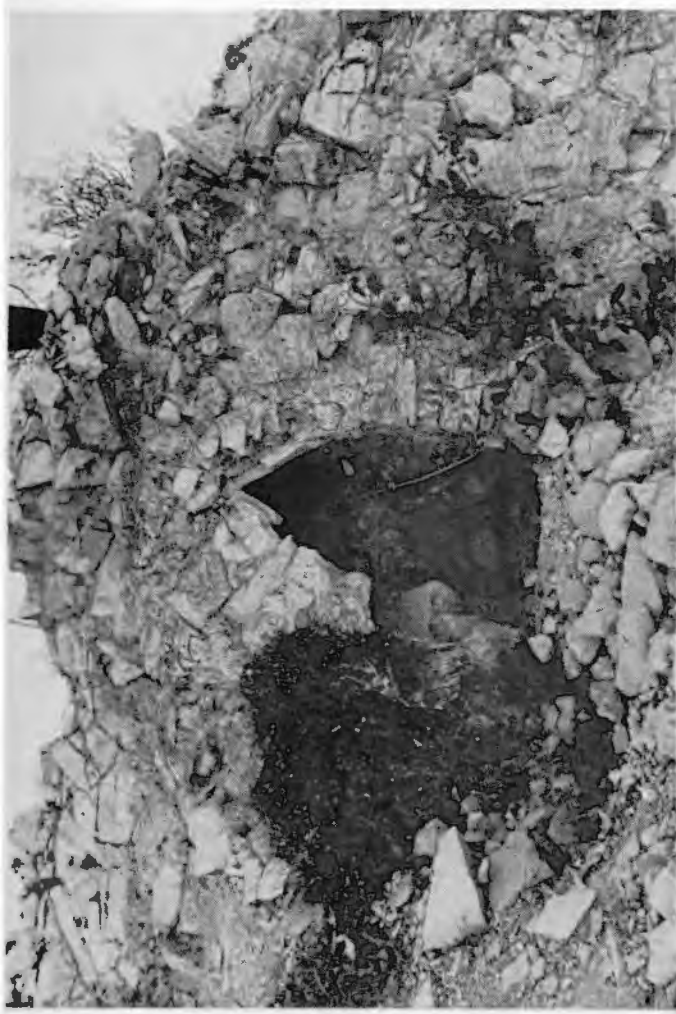
Pl. VIIb. Detail of masonry with embrasure in the Ashiaba lookout post.

Pl. Xd. Section through Maydan enclosure wall revealed by down-cutting flood action, showing masonry "lifts". Note irregularity of some of the stones which match those of Ashiaba (see Pl. VIIb).

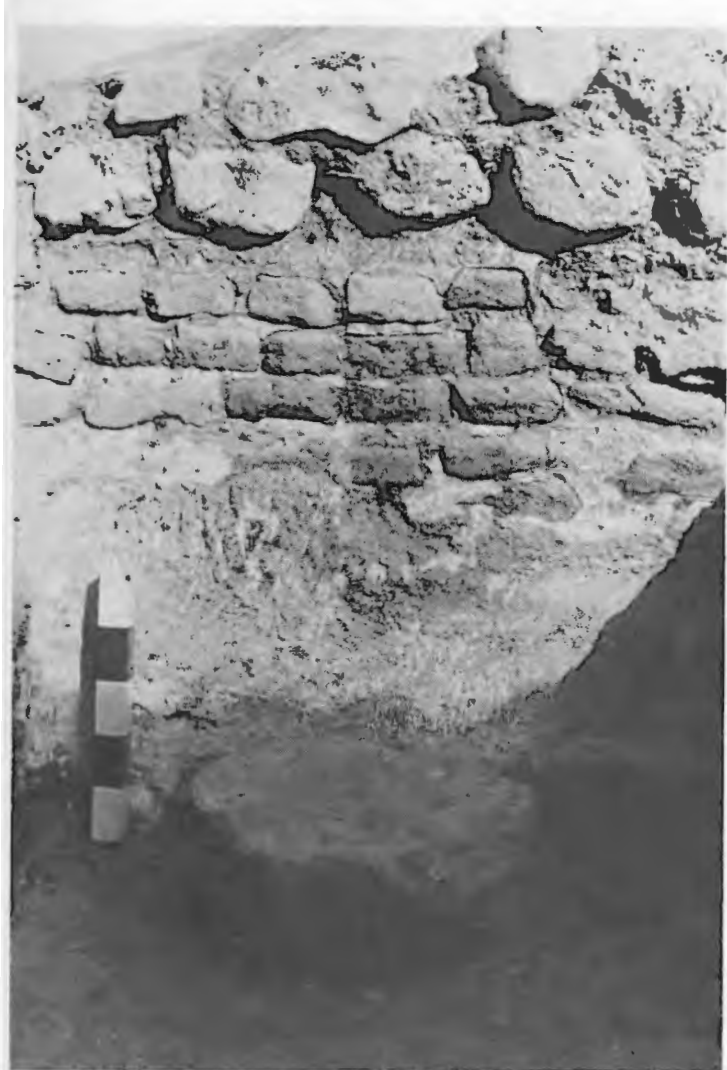
*Pl. IXa. Rubble masonry built above Parthian brickbats in room 12, Kala Dawar.*

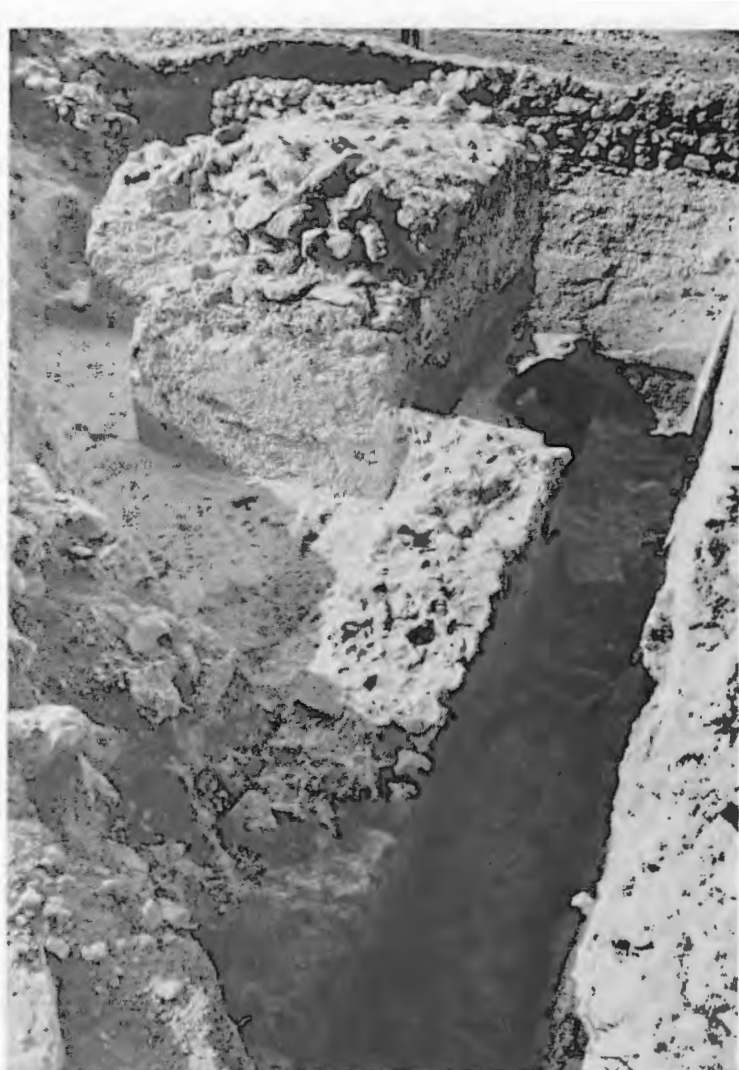
*Pl. IXb. L-shaped pier and blocking wall in corridor of Kala Dawar chahar taq (areas 7 and 12).*

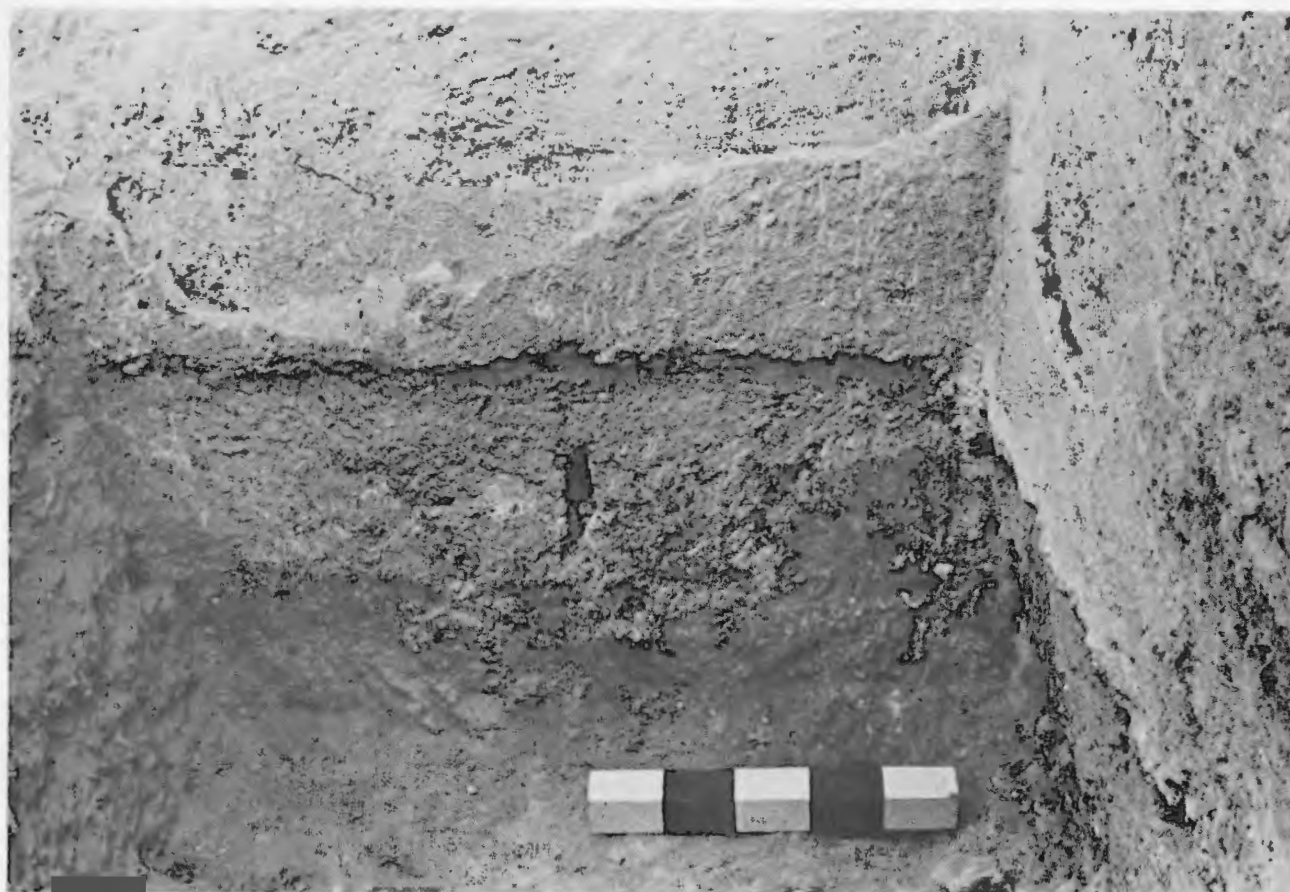
*Pl. IXc. Plaster intact upon wall face of Sasanian period, at floor level, in west corner of corridor 7, Kala Dawar.*

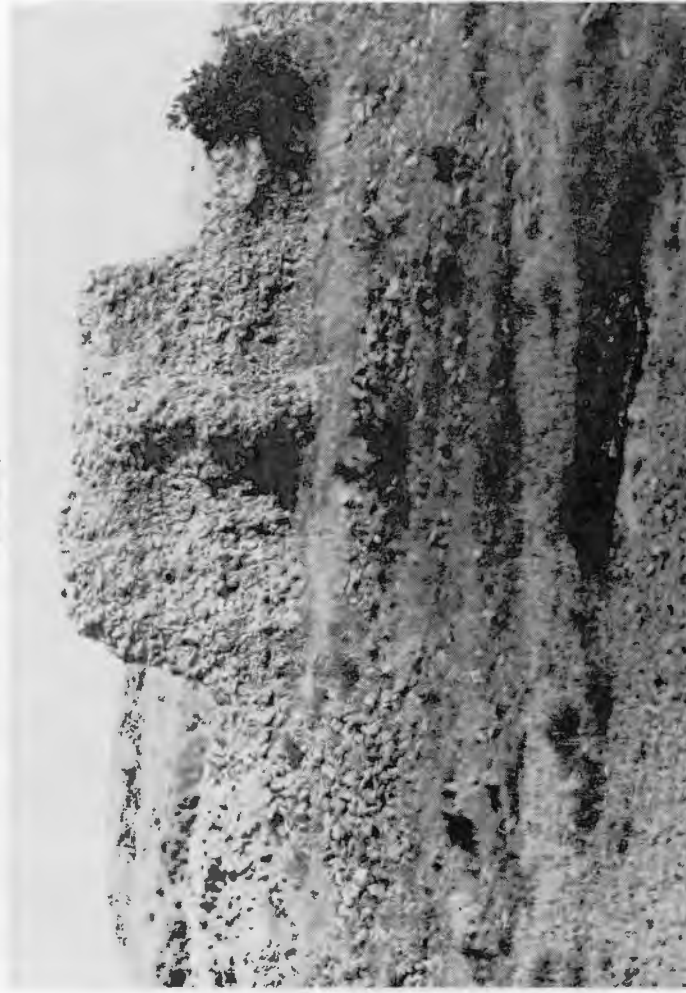
Pl. Xc. Detail of wall with interior buttress at southwest corner of Maydan enclosure.

The Maydan perimeter wall is buttressed on the inside, as evidenced by the three free-standing portions of wall at the extreme southern end of the west side (Pl. Xc). The slender dimensions of the wall, together with the presence of buttresses which would have no defensive practicality, were the beginning for the hypothesis that the enclosure was non-military in nature. Examination of the surface within the Maydan indicates that the space was apparently devoid of structures at the time when the Gach Gumbad complex was occupied at the north end. Pottery was found much less often in the fields of the Maydan enclosure than it was on the slopes of the nearby Tepe Rash ridge. It would be logical

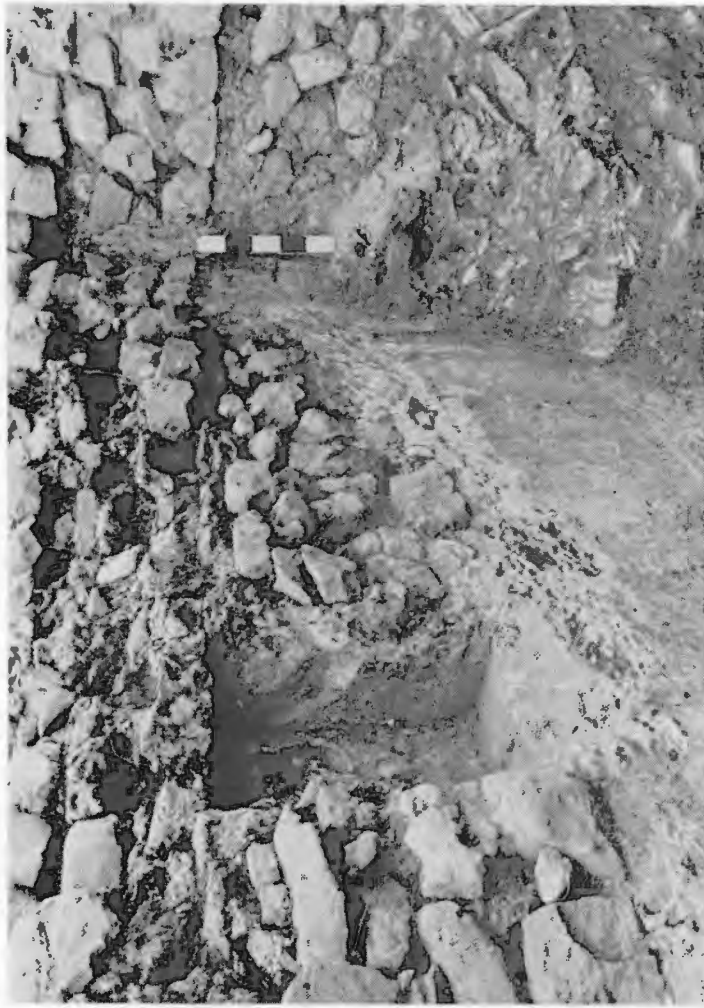
Pl. XIIb. Gach Gumbad West: a flat arched niche in corridor 219.

Different forms of arch are present in the complex: in the corridor of area 19, a small niche, constructed of rubble masonry, is capped by a flat arch (Pl. XIIb). The doorway between areas 201 and 211, also of rubble masonry, has a rounded arch (Pl. XIIId). (In the illustration, the keyhole effect of the doorway silhouette is probably due to the way the masonry has been preserved, rather than an indication of its original shape; the top part of the arch was exposed above ground and its surfaces have eroded to a greater extent). Apart from the round arch of the doorway just mentioned, the site contains other examples in one of the towers of Ja-i Dar, which has extant round arch forms in rubble masonry for a main corridor and a side passage vault (Pl. VIIa, b). Again, there is no ready explanation as to why the builders constructed their arches in different ways, although there is a possibility that it is related to the width of the particular span, and to load-bearing considerations. It is generally acknowledged that bricks could be employed in the construction of a vault without centring. It is less certain in the case of rubble masonry. Whatever the case, it does not explain satisfactorily why spaces of like proportion are sometimes covered by brick, sometimes by rubble masonry.

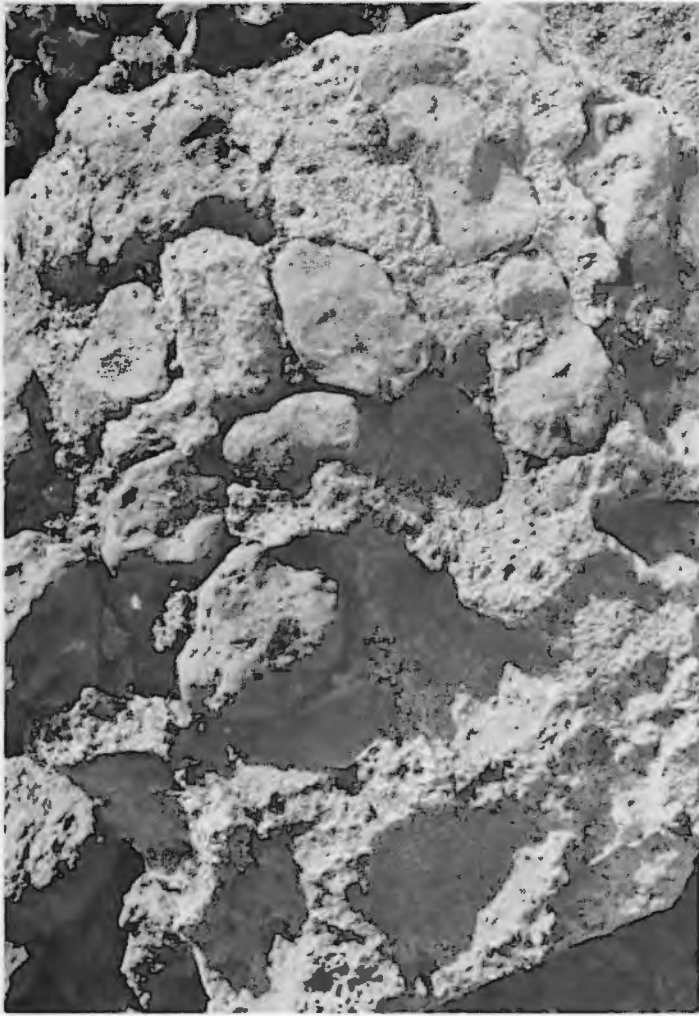
*Pl. XIIIa. Masonry of corridor 12 vault.*

With regard to masonry types, some general observations can also be made. The rubble masonry of the Gach Gumbad structures as a whole belongs to the standard type in which horizontal lift divisions are visible in the exposed surface of the wall faces (Pl. XIIb). (Of course, these would not have been visible in antiquity when the plaster surface was intact). One interesting phenomenon which emerged from the excavations is the use of different building materials for arches and vaulting. In area 210, the arches between the piers of the arcade are built of rubble masonry, like the arcade piers themselves. The exposed (broken) top of one of these arches can be seen in Pl. XVIa. By contrast, the fallen fragment that appears in the section of area 201 at floor level is of baked brick (Pl. XVIb-d). Its curvature is different from that of the arcade arches themselves, and from its considerable size and its position at floor level, one must conclude that it lies where it fell. A reasonable explanation would be that it represents vaulting along the length of the arcade. Elsewhere, evidence of a rubble masonry vault is to be seen in the debris associated with the corridor of area 12. Pls. XIIIa and XIIIb (and see

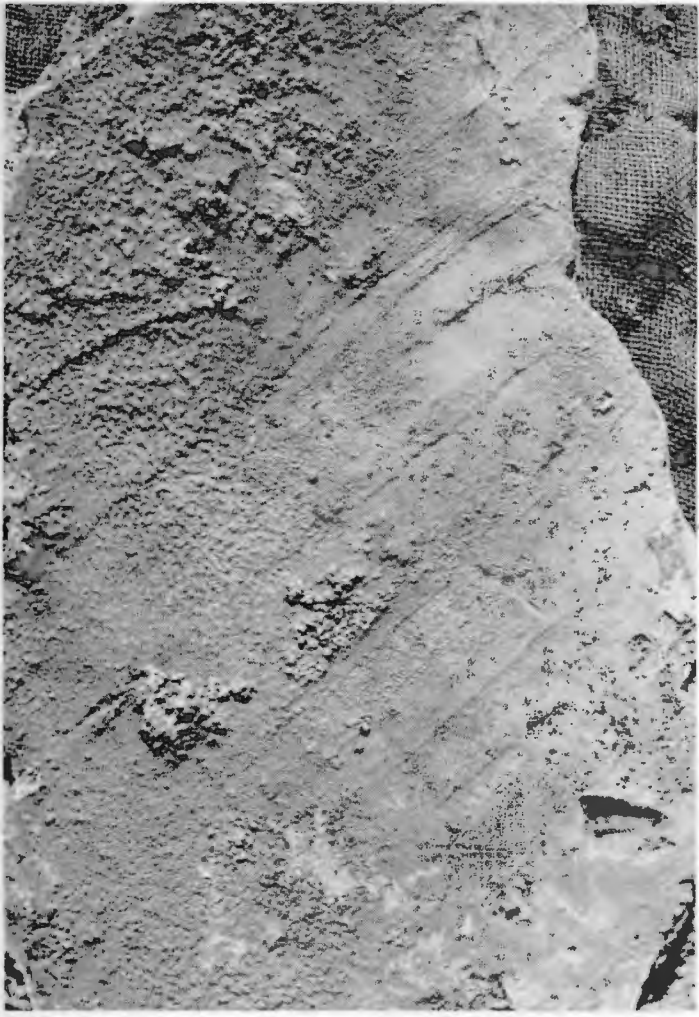
*Pl. XII lb. Plasterer's trowel marks on underside of corridor 12 vault fragment, Gach Gumbad.*

Pl. XVa) illustrate what must have been a very shallow, almost flat vault of masonry. The tool markings of a plasterer's trowel, seen on the plaster still adhering to the underside of the fallen fragment, suggest that once the masonry was erected in place, presumably with some use of centring, the surface was plastered over to furnish the eventual finished surface.

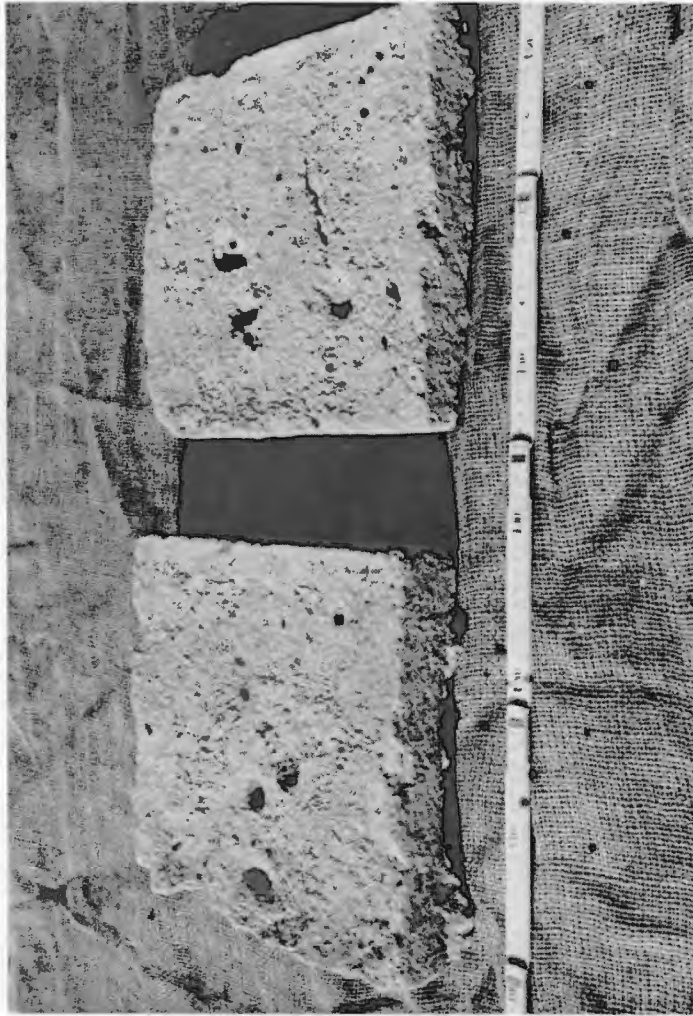
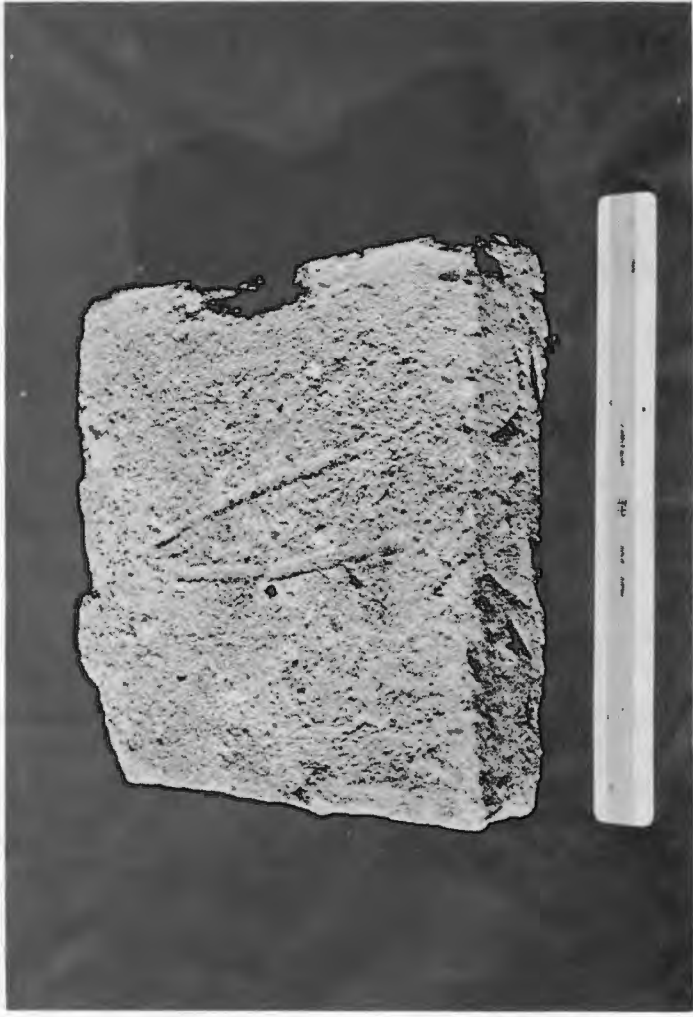
*Pl. XIIIc and d. Typical Parthian-period baked bricks, showing workman's trademark.*

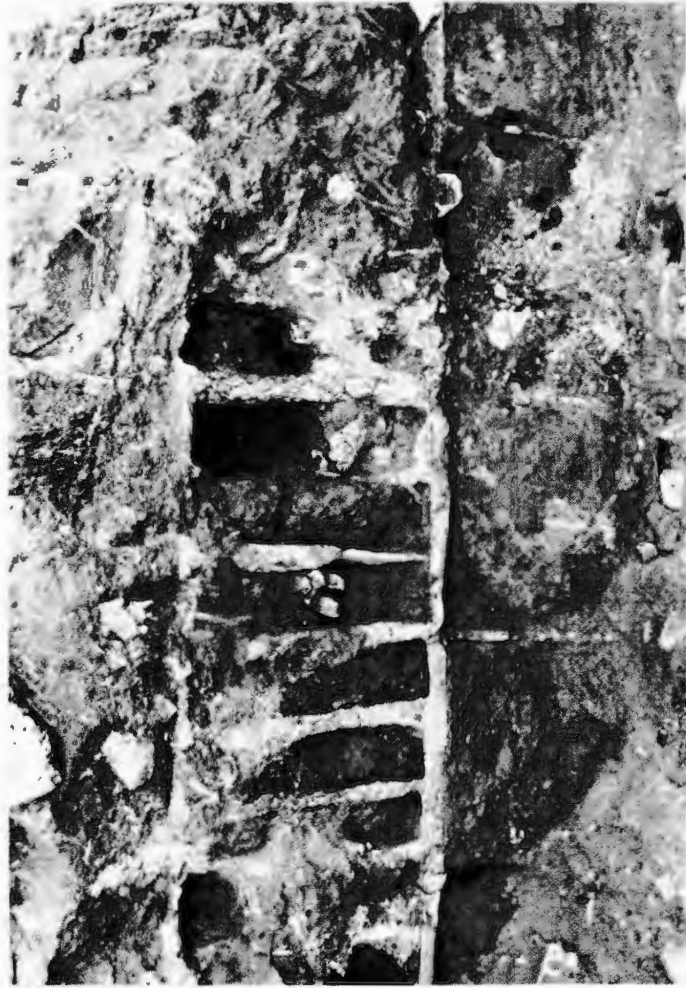
Pl. XIVa. Vertical brick lays in corridor 21, Gach Gumbad.

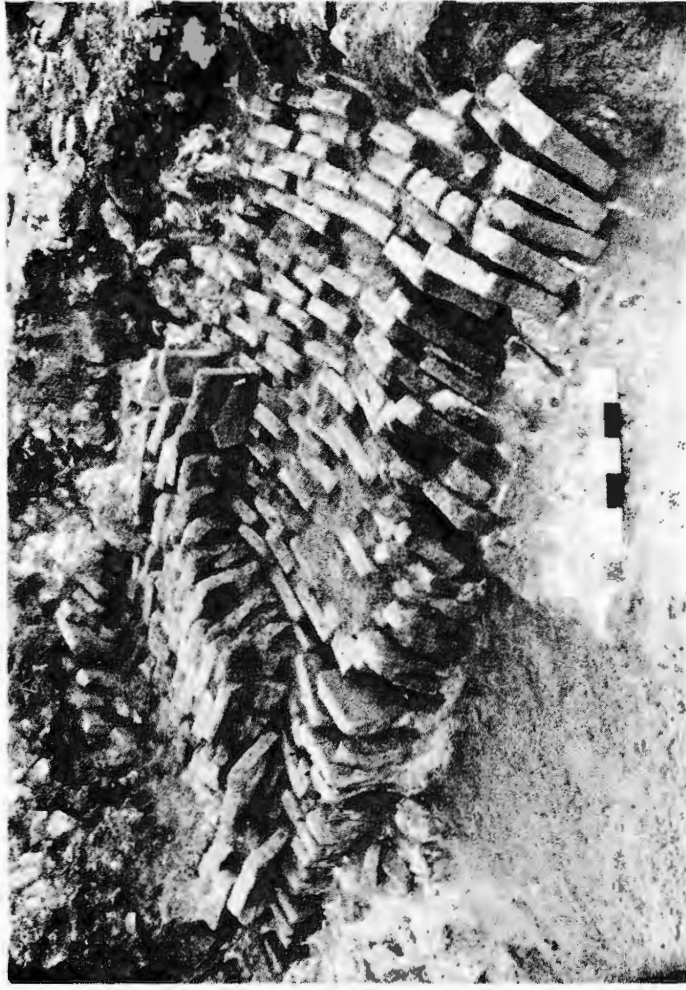
Pl. XIVb. Vertical brick lays between areas 82 and 73, Gach Gumbad.

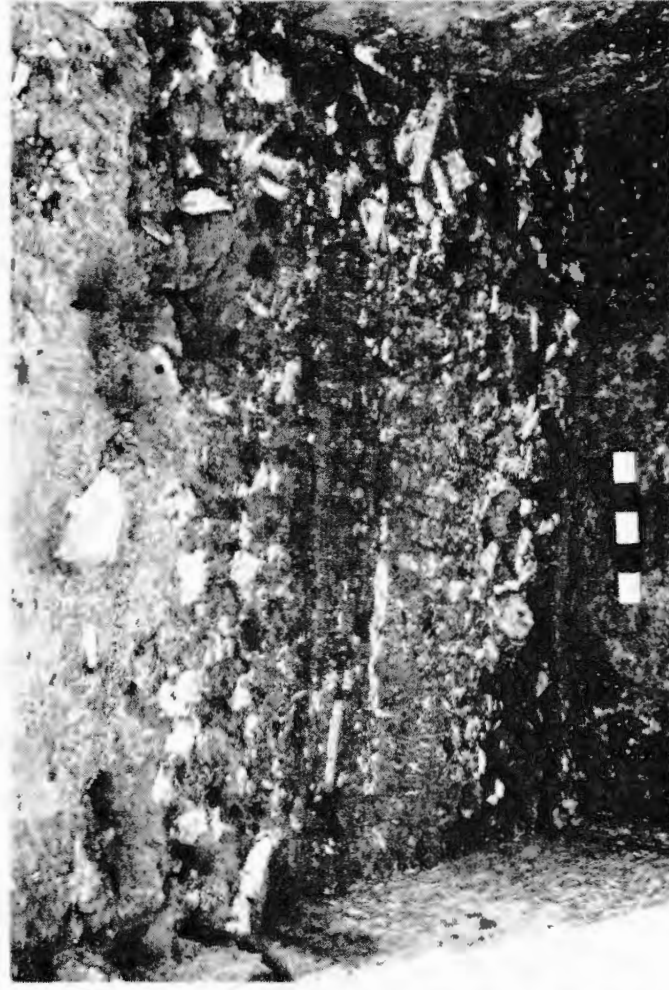
Pl. XIVd. Typical corridor section showing full plaster and soil from decayed bricks. Corridor 91, Gach Gumbad.

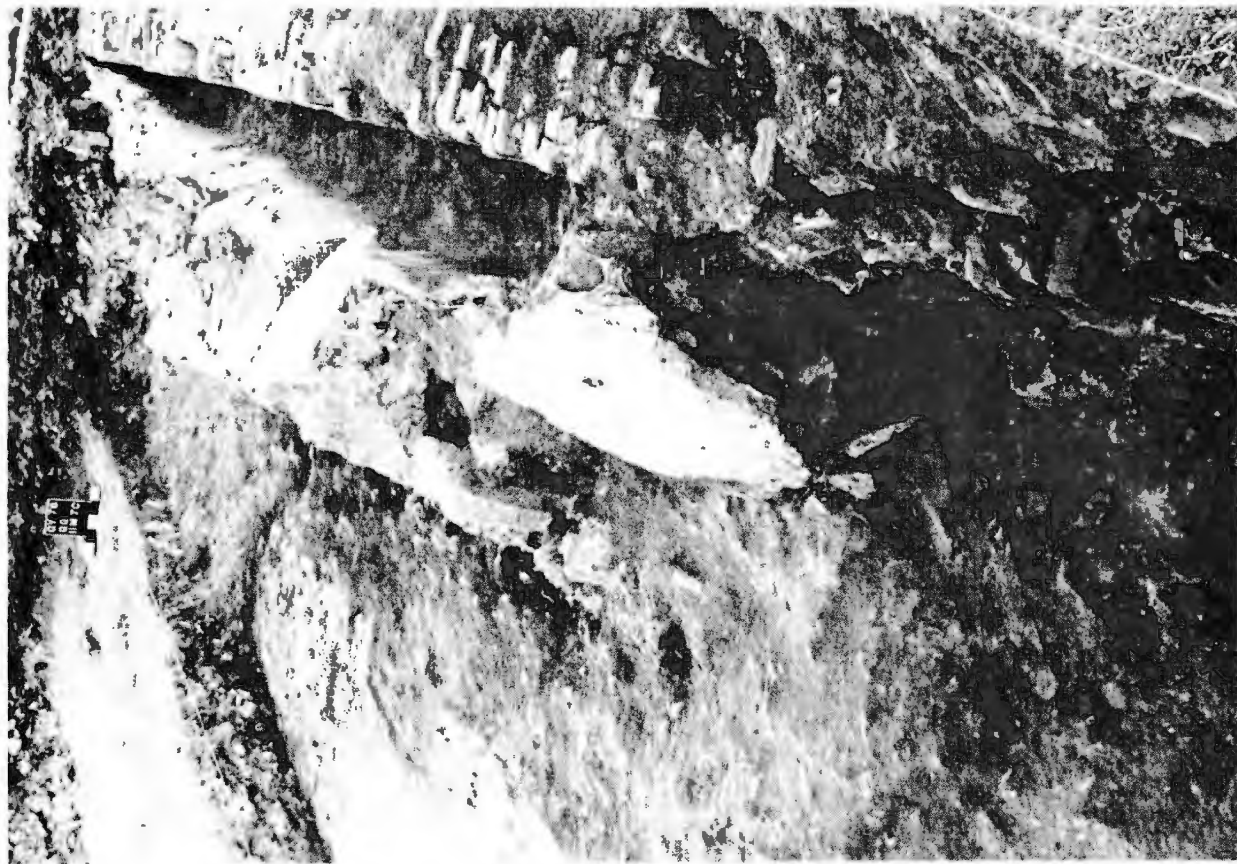
Pl. XV'a and b. Collapsed first floor vaulting from corridor 12, Gach Gumbud.
