**QAL'EH-I YAZDIGIRD**  
**An Overview of the Monumental Architecture**

**BY**  
**EDWARD J. KEALL**

*Reprinted from*  
**IRAN XX 1982**

*Published by*  
**THE BRITISH INSTITUTE OF PERSIAN STUDIES**

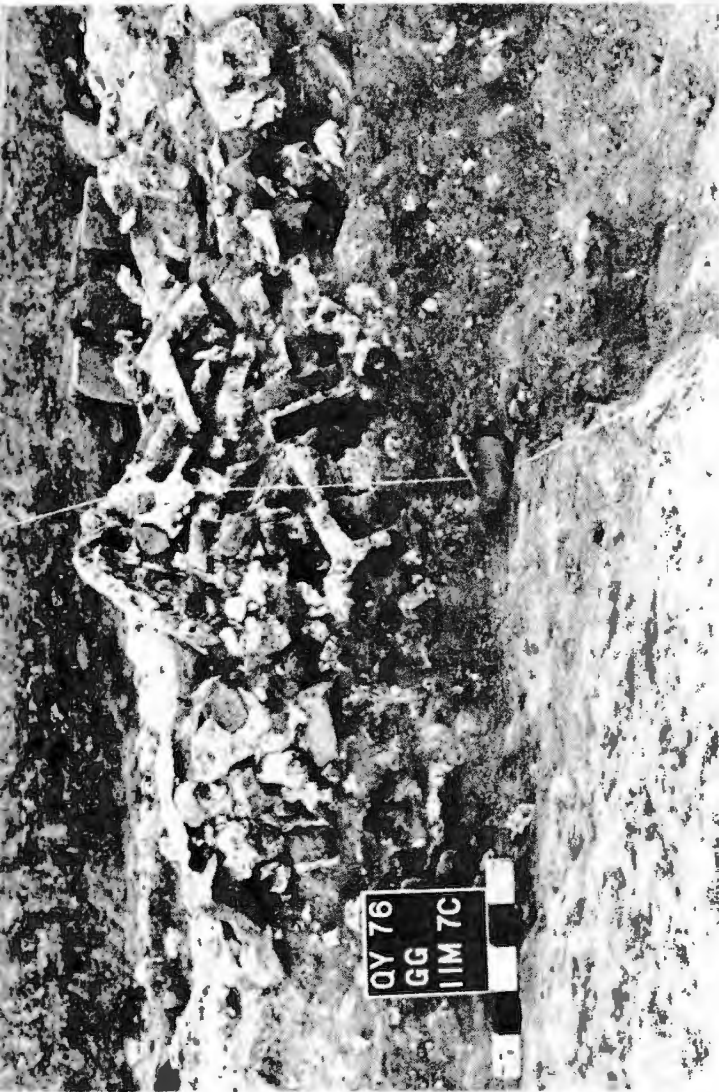
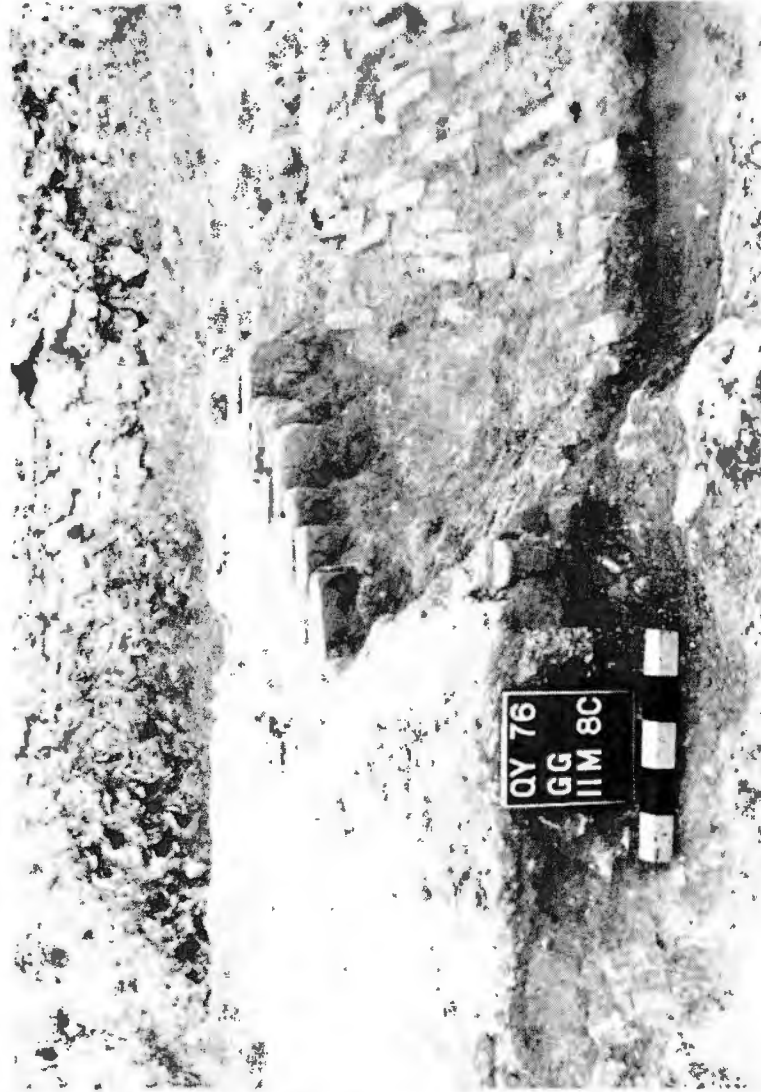
Pl. XVc. Vertical brick lay construction, east side of area 14, Gach Gumbud.

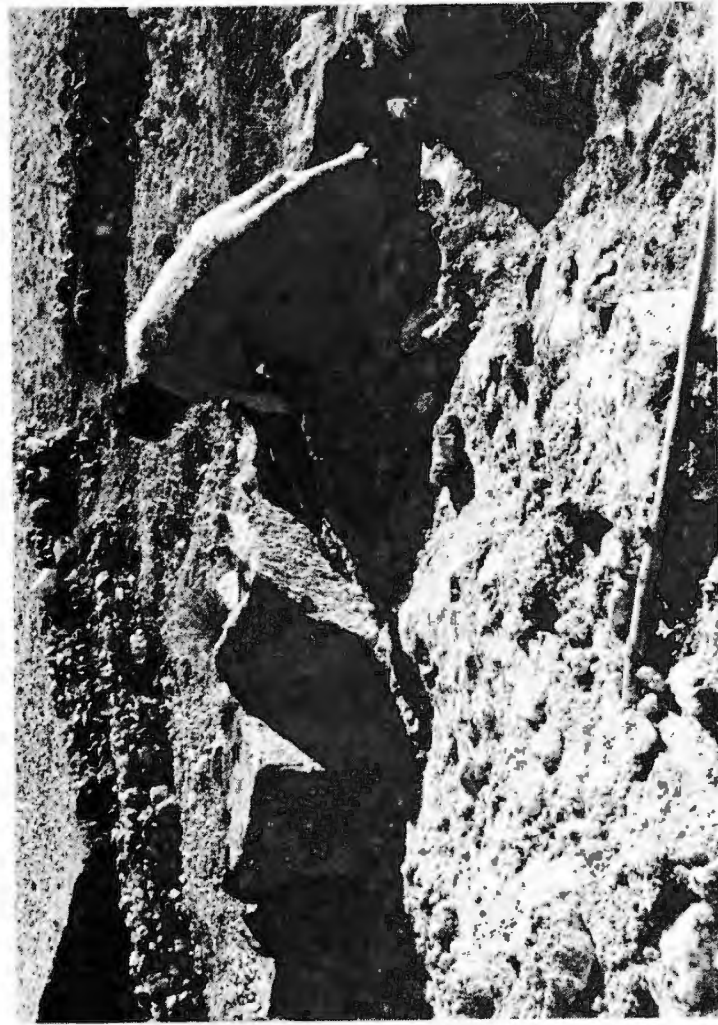
*Pl. XVIa. Broken top of in-situ rubble masonry arch of arcade, area 201, Cach Gumbad West.*

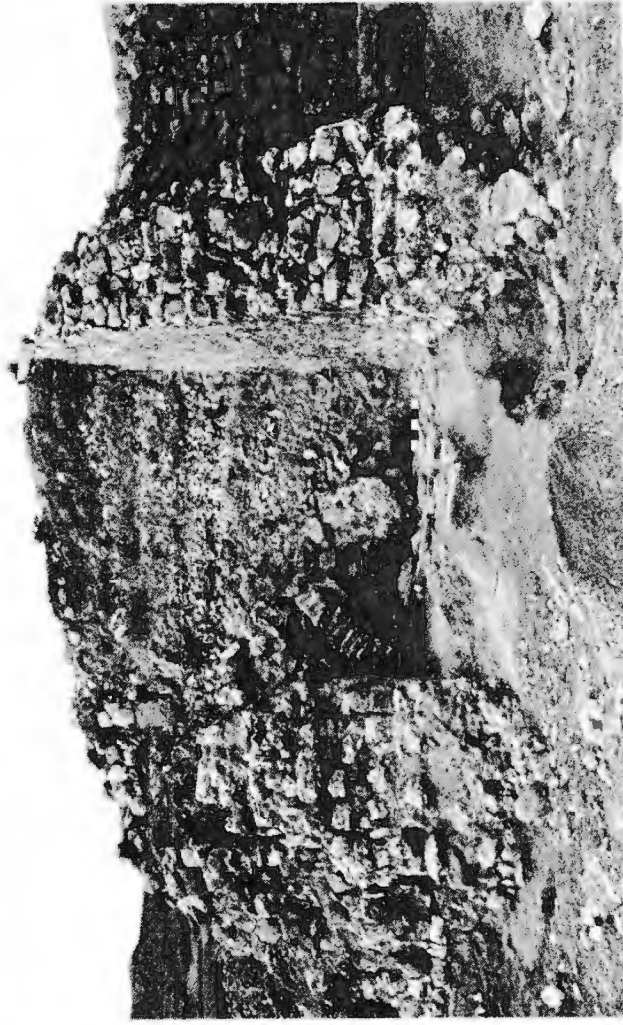
*Pl. XVIb. North-south section in debris of area 201, showing fallen vaulting behind arcade pier.*

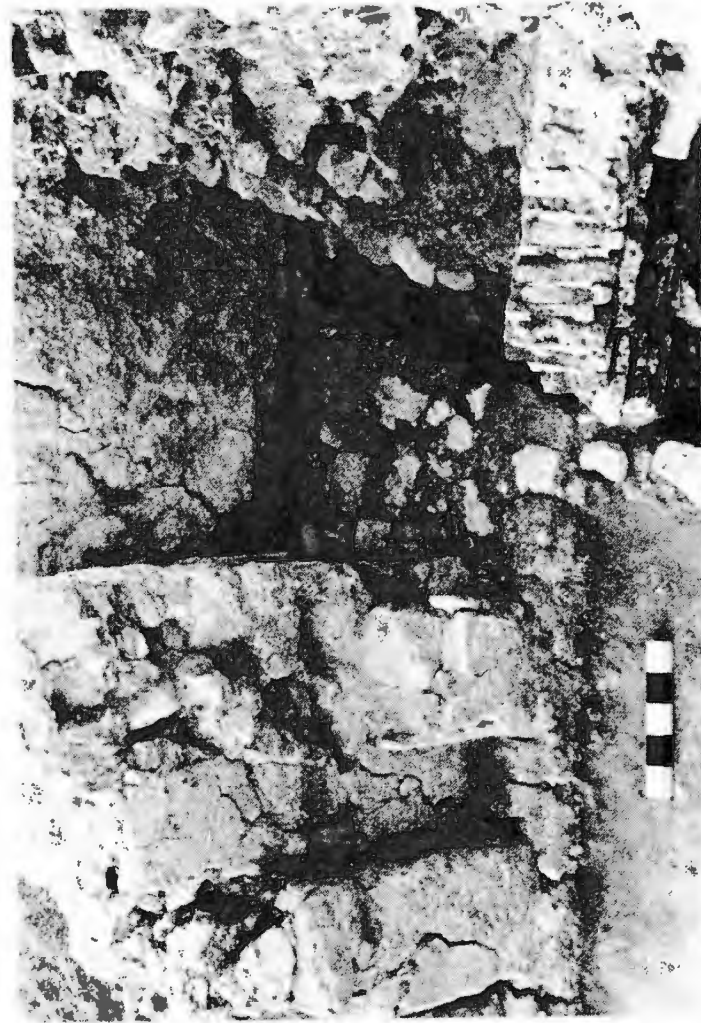
*Pl. XVIc. Baked brick vaulting fallen along side articulated pier of arcade, area 201.*

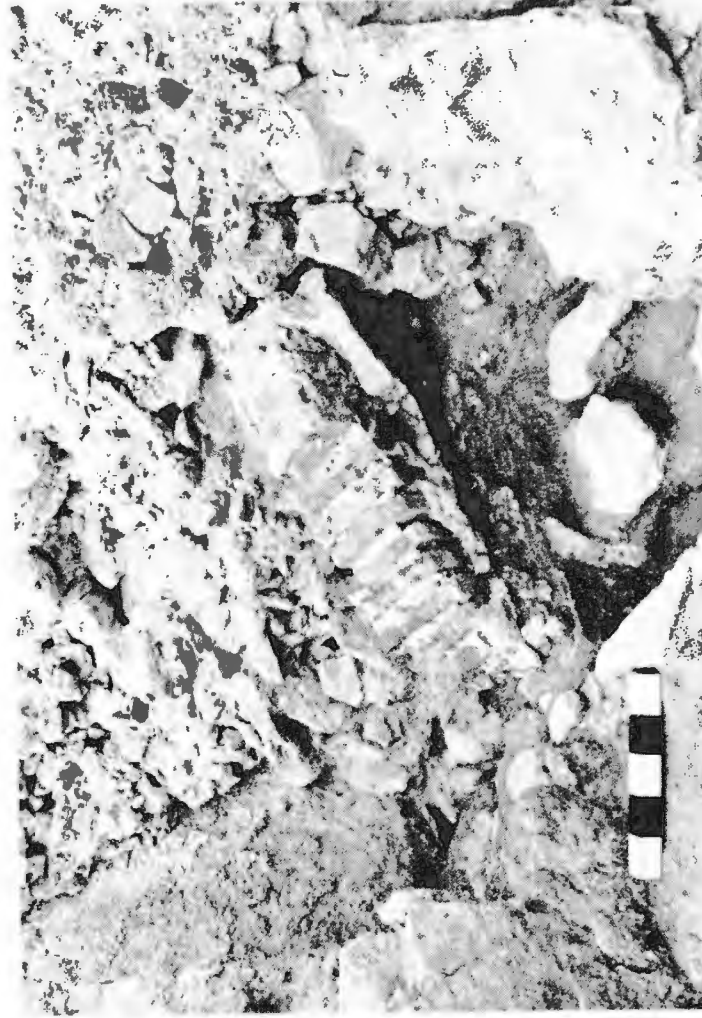
*Pl. XVIId. Detail of fallen baked brick vaulting from area 201.*

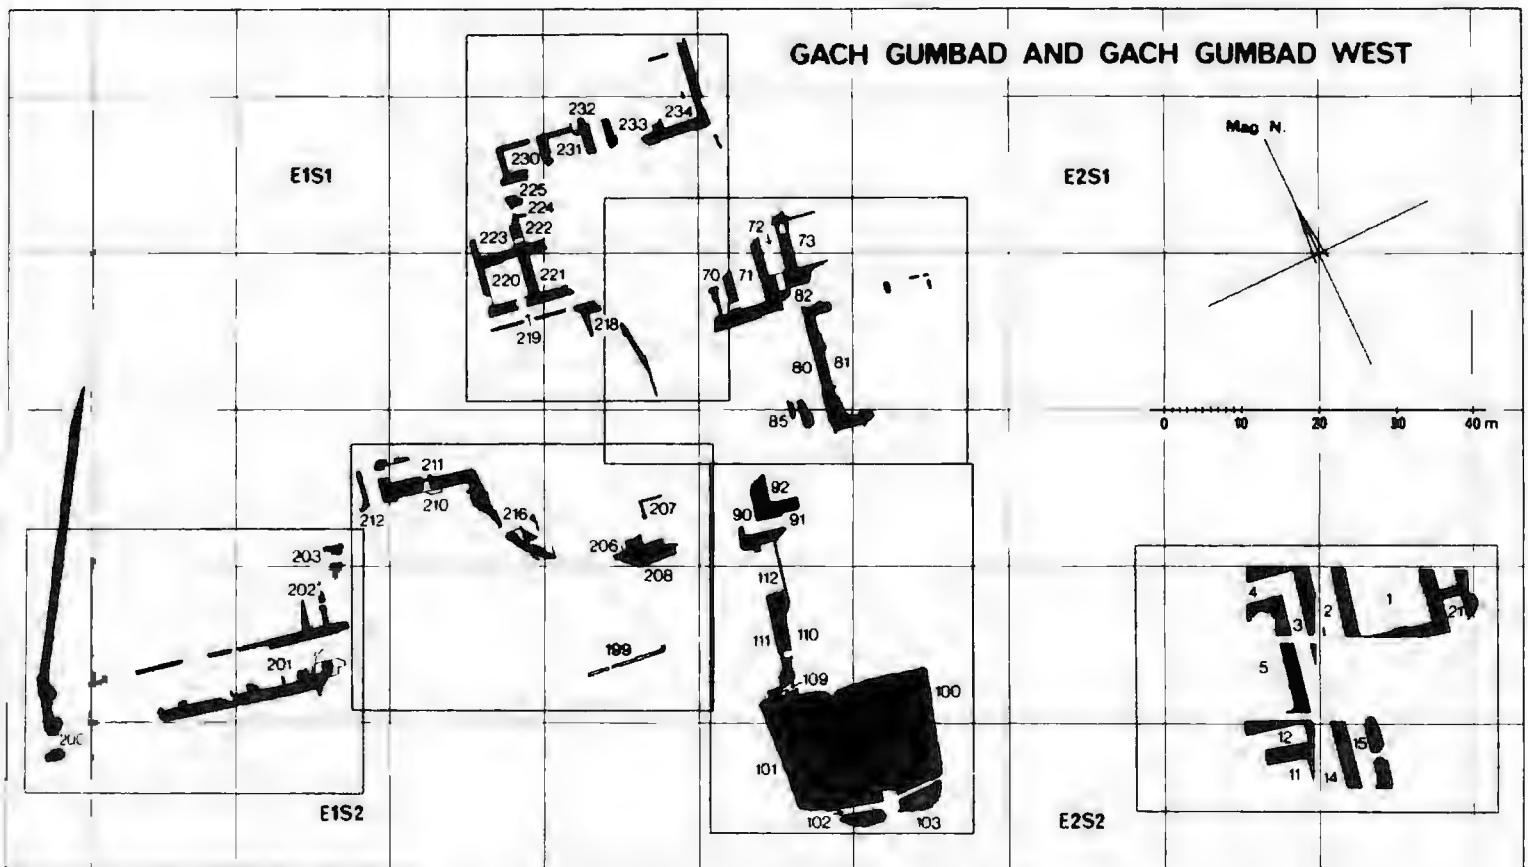
Fig. 10. Plan of walls of the palace, as excavated 1976-79.

The 1978–79 season revealed that, while the surface traces of walls on the west side could indeed be corroborated as being a reflection of a real building plan, the widening and down-cutting of the gully bed as it exists today appears to be a phenomenon that has occurred almost entirely since the building of the Parthian structures. By reconstructing in plan even a part of the rooms that have been swept away by flood waters, one must envisage at most a very modest watercourse at the time when the buildings were functional (compare Figs. 9 and 10).

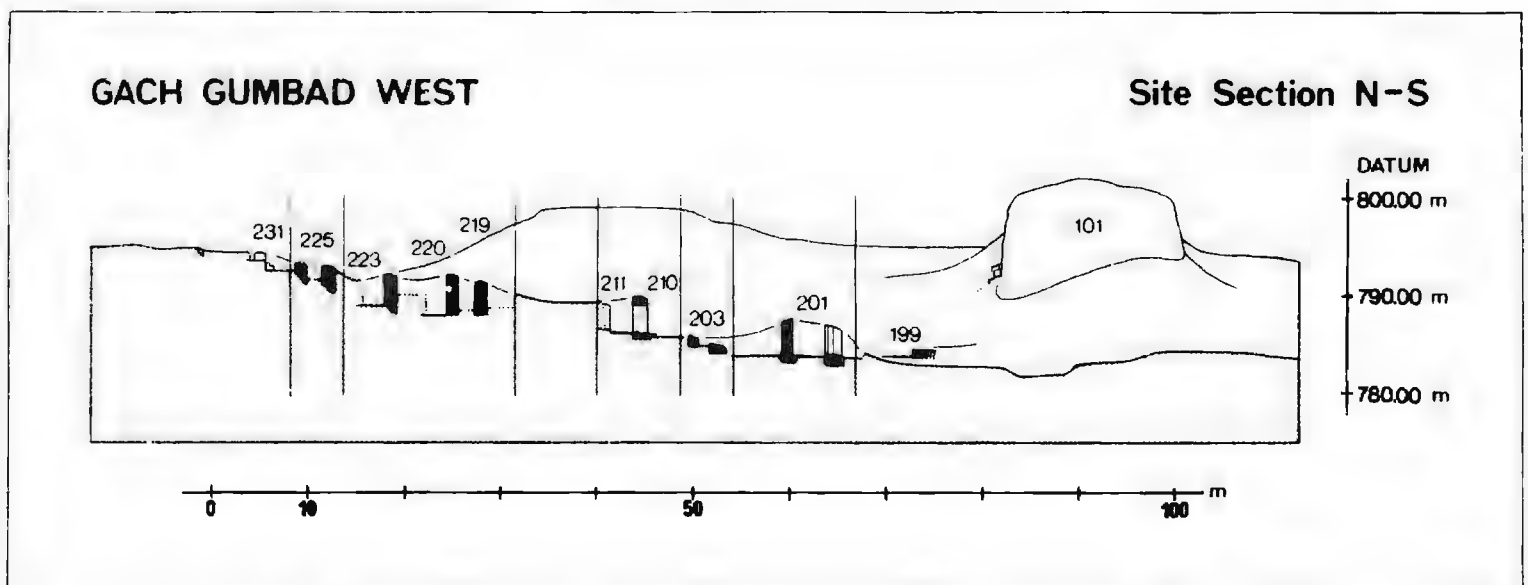
Fig. 11. Section showing drop in elevation accommodated by groups of rooms at different levels.

Reaching an understanding of how the whole palatial complex functioned is difficult without further excavations. At the end of the 1978–79 season, however, a remarkably consistent building formula was beginning to emerge in the layout of the complex on the west side of the gully. The bedrock here consists of a series of shale and soft rock strata which have fractured, leaving distinct “steps” in the ground. The architects have accommodated this feature by erecting a series of small chambers along the natural contour whose southernmost limit is represented by corridor 225; the next series of chambers was erected at the substantially lower level in which corridor 219 occurs (Figs. 11

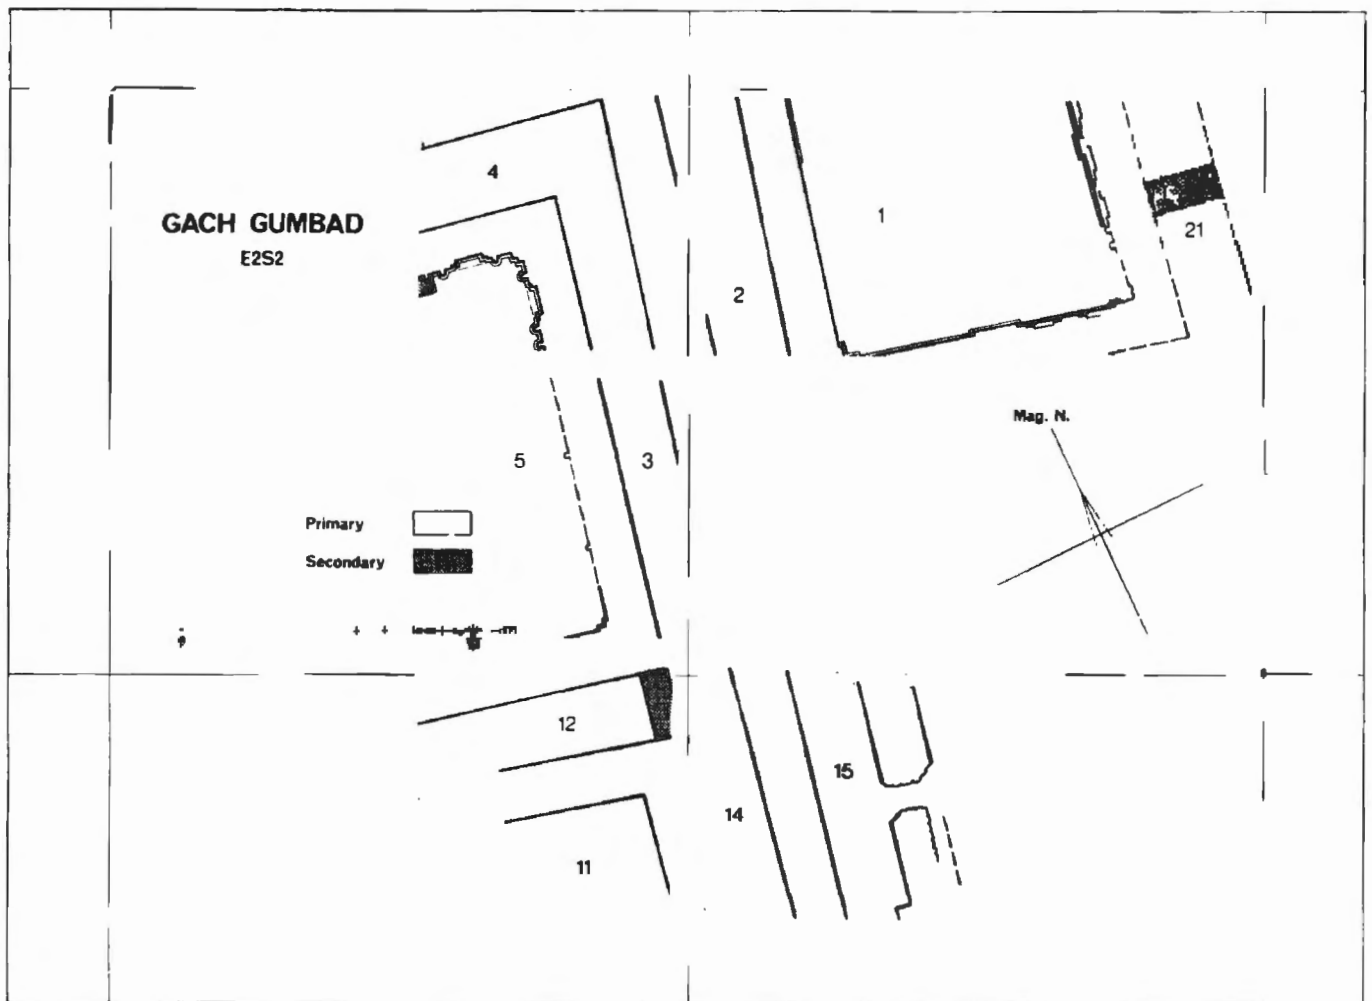
Fig. 12. Baked brick walls of the main halls. The east wall of area 15 is of rubble masonry.

The three large, heavily ornamented halls on the east side of the gully (Fig. 12) remain the most important formal element so far found in the complex. A series of corridors surround them. At present only parts of the halls have been excavated, but what has been exposed bears a likeness in plan to the north *eyvan* unit of the Parthian palace at Ashur.<sup>9</sup> The distinctive feature of these walls, apart from the plan, is the use of baked brick, stacked on edge, and laid at right angles in alternating courses (Pls. XIVa, b, c; XVb). The engaged half-columns of area 5 were also executed in vertically stacked bricks. A crucial discovery of the 1976 season was that the east corridor wall of area 15 was constructed of rubble masonry, rather than of baked brick like the other excavated corridor walls. This is the outer wall of a double corridor. Although the building can be seen to extend further east immediately to the north, the fields directly to the east show no traces of further wall remains, and the rubble wall at this point seems to represent the easternmost limit of the building (compare Figs. 6 and 9).

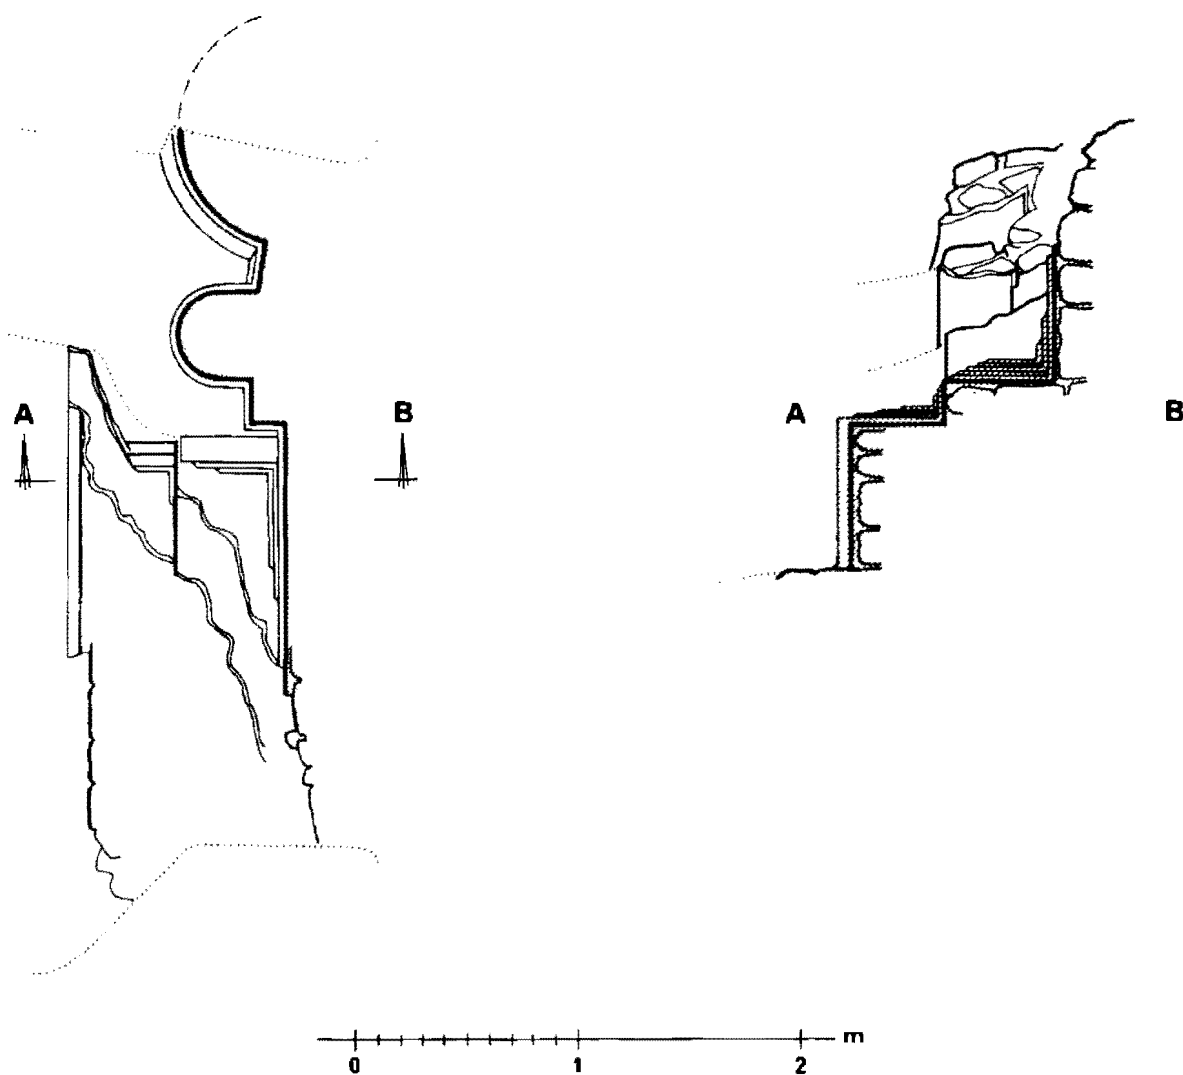
**GACH GUMBAD****Area 101**

Fig. 16. Left. Plan of the articulated north face of block 101.  
Right. Section through line A-B.

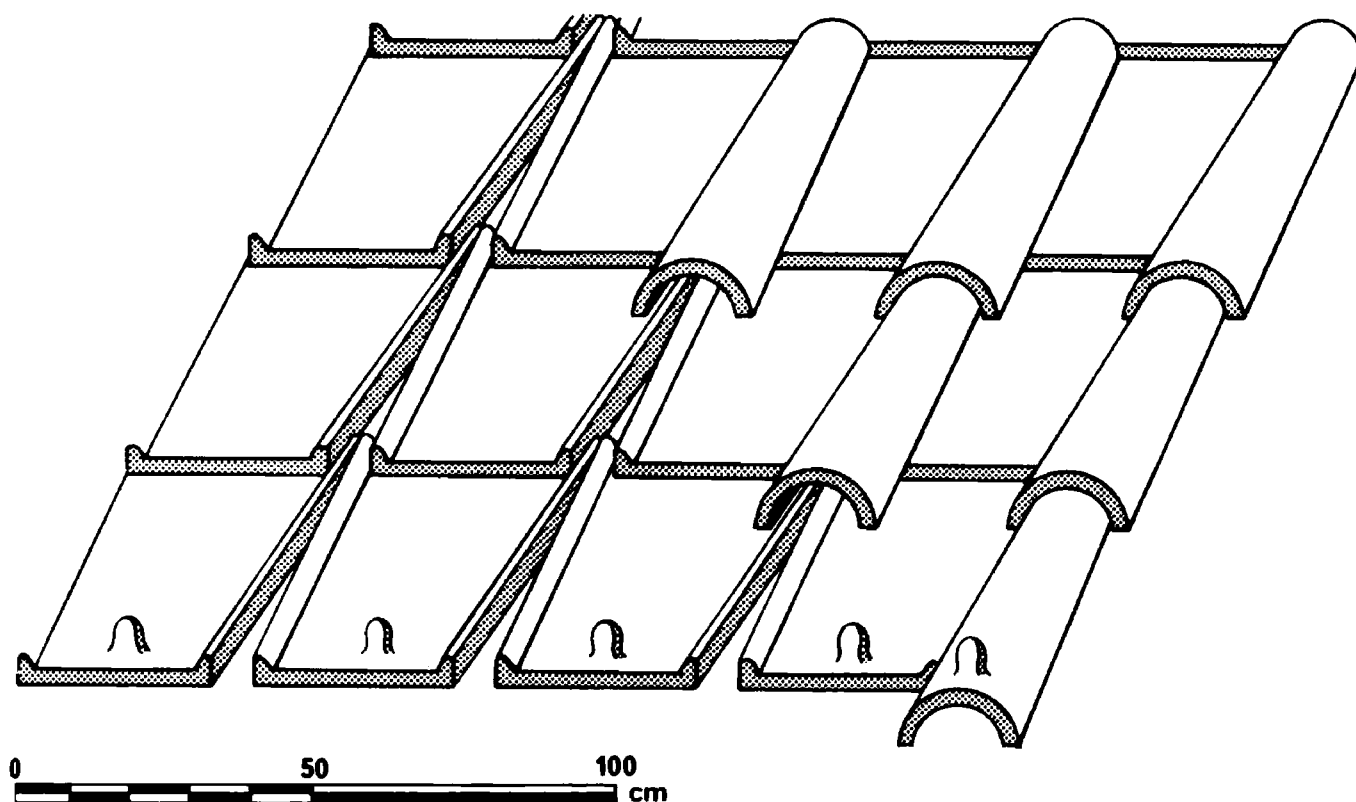
Fig. 20. Reconstruction of the layout for ceramic tile roofing. Note the terminal "antefix" tabs.

One of the most puzzling elements of the whole site is the presence of ceramic roof tiles. Numerous tiles have been recovered from all over the surface of the Maydan enclosure, in contrast to the area outside it. They appear to have come from Gach Gumbad. There are no obvious traces of buildings within the enclosure to explain the occurrence of tiles in this area. Furthermore, observation has proven that heavy sherds can move considerable distances from their former place of deposition because of ploughing and erosion,<sup>10</sup> and the presence of the roof tiles some distance south and downslope of Gach Gumbad is not inexplicable. The tiles include a large, flat pantile which was designed to have the upturned flanges covered by a round tile (Fig. 20). The largest near-complete fragment of the flat tile found measured 43.9 cm. long, 39.5 cm. at the top end, and 33 cm. at the bottom end. The tiles were tapered, obviously, to permit one to fit over the end of another between the flanges on either edge. Crude tabs were found attached to certain of the tiles, suggesting that even in their decorative aspect there was a memory of the western origin of this particular type of roofing.<sup>11</sup> The tabs seem to be a vestige of what in the Classical world would be termed an *antefix*. The *antefix* and the tiles themselves make no sense in the arid climate of western Iran, other than by explaining them as an example of cultural influence. It does rain in the Zardeh basin between November and early April. These rains are heavy but intermittent; in January there can be wet snow, though it does not last long on the ground at this altitude. The traditional flat, mud roofs of the modern village appear to be adequate to cope with the requirements of the climate.
