**QAL EH-I YAZDIGIRD: ITS ARCHITECTURAL  
DECORATIONS**

**EDWARD J. KEALL, MARGARET A. LEVEQUE and NANCY WILLSON**

*Reprinted from*  
**IRAN XVIII 1980**

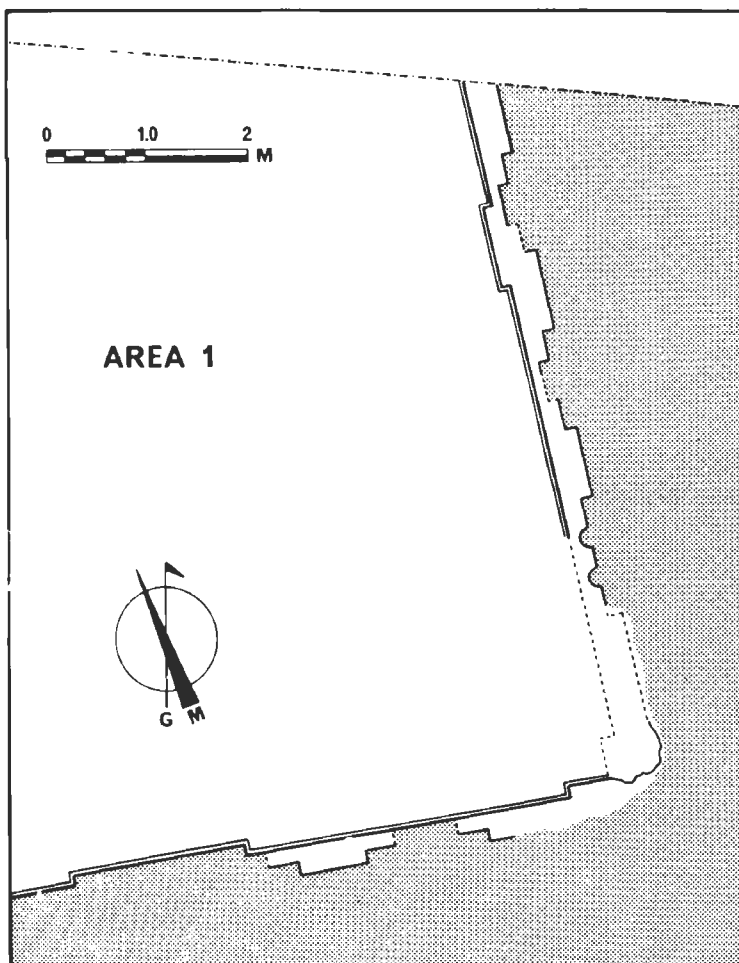
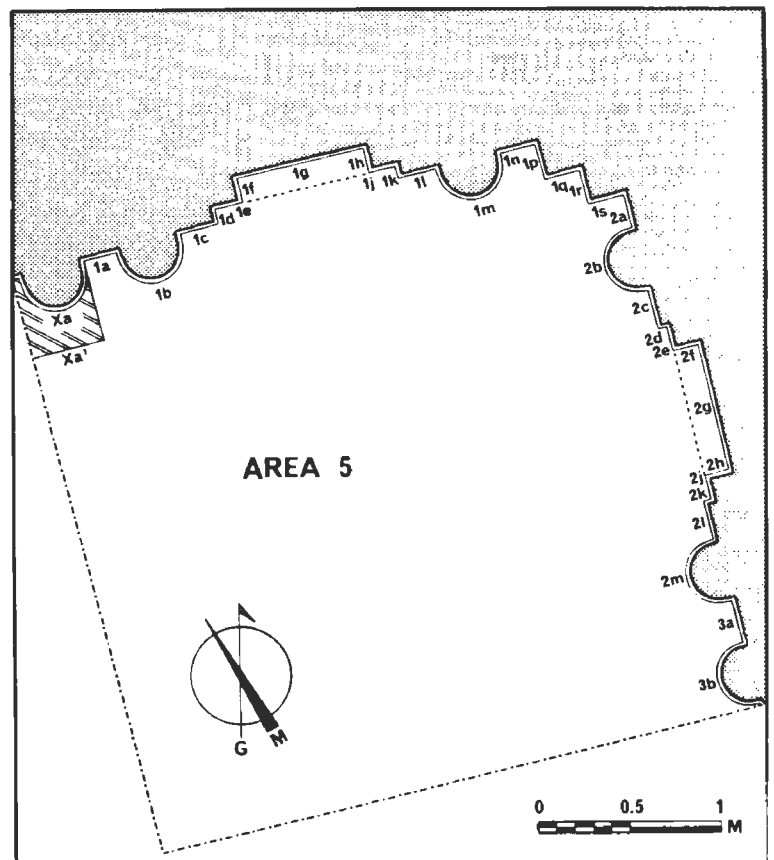
Fig. 2. 1. Area 1, plan; 2. Area 5, plan.

In 1975 a secondary deposit of stuccoes was found in the context of an ancient dump of architectural debris, outside the long-walled Maydan enclosure (Pls. IIa and IIIa). Evidence of dumping activity was duplicated in 1978–79 by the discovery of stucco-filled debris which seems to have been deliberately poured down into a ruined cloister (Grid W1S2, area 201), on the west side of the Maydan gully (Pl. IIIb and c). This was done after the cloister had been blocked up by a solid wall in a drastic remodelling scheme. More modest in scale, but still indicative of repairs being made, is the buttress that was added as reinforcing in area 5 to the half-column of niche “xa” (Fig. 2, no. 2).

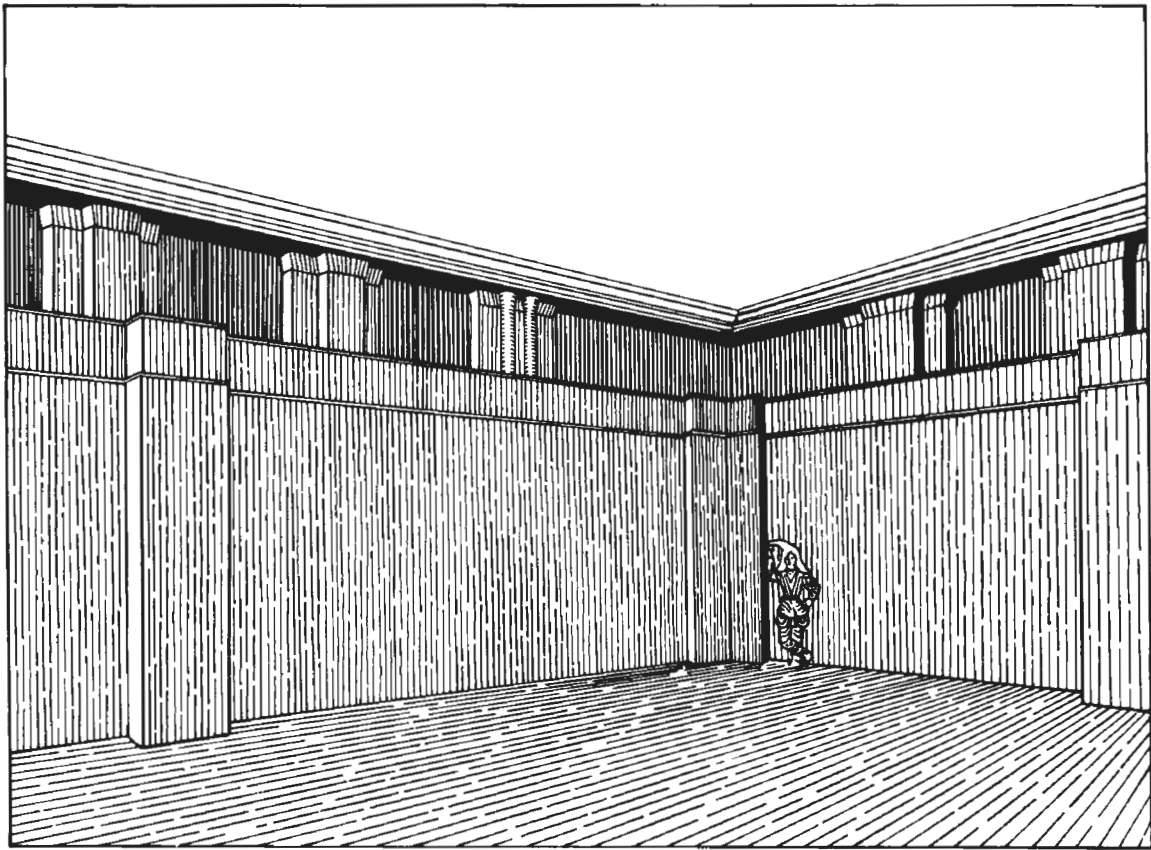
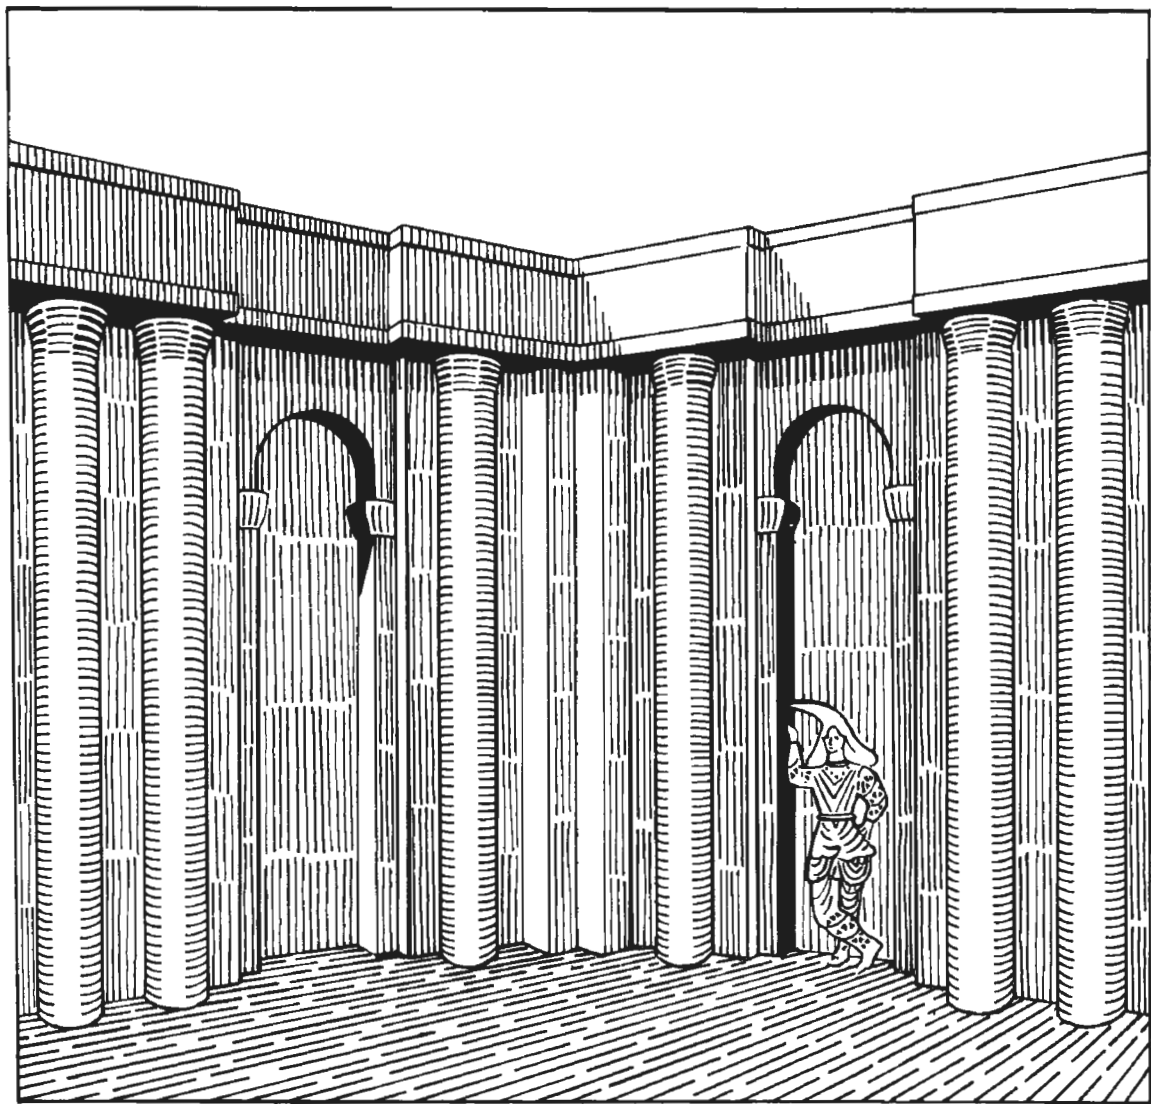
Fig. 3. 1. Area 1, conceptual reconstruction; 2. Area 5, conceptual reconstruction.

Fig. 3, nos. 1 and 2 have been prepared to give some idea of the scale of the rooms of the structure. In the case of area 1, it has already been mentioned (*Iran XV*, p. 6) that there was an indented feature above the swastika and roundel frieze, which may be related to a gallery at the top of the wall below the springing of the vault (Pls. Ib, c and IVa, b). In the reconstruction drawing, the details of the frieze have been omitted, but the profile of the indentations above have been given, including the two fluted half-columns (see also Pl. XIVa and Fig. 24). No reconstruction of a vault has been offered.

For area 5 (Fig. 3, no. 2), the reconstruction has been proposed without knowing whether the niches ran full height from the floor or whether it will transpire that they are the upper tier of a double set of niches. The uppermost frieze of the reconstruction drawing is also an arbitrary way of presenting the entablature above the engaged half-columns. As can be seen from Pls. Va and VIa, very little of the entablature has survived *in situ*, but the presence of capitals (especially those from Fig. 14) close to the walls in the debris at this height suggests that the tops of the columns may have been approximately at this level.

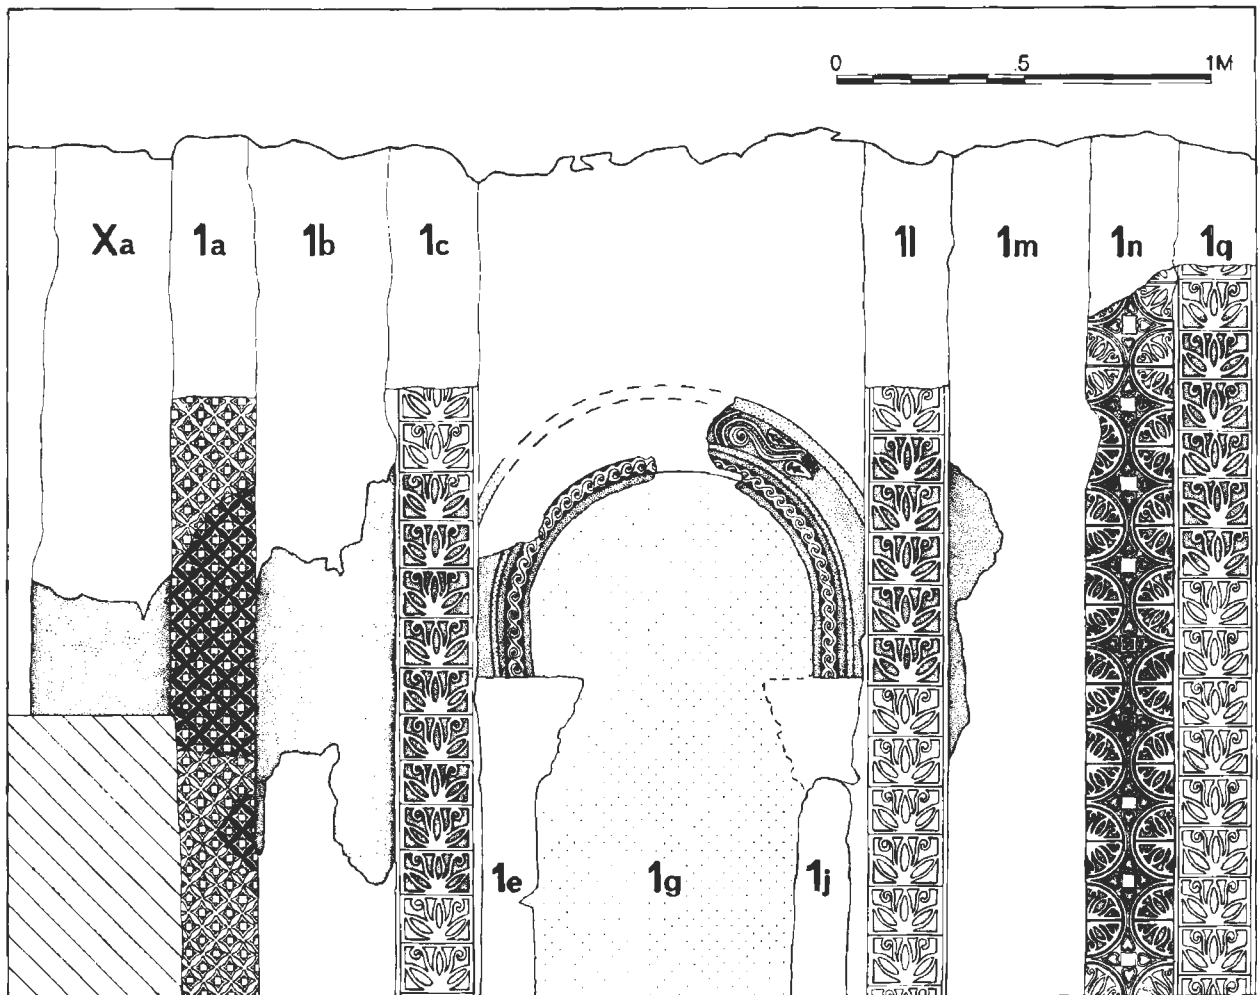
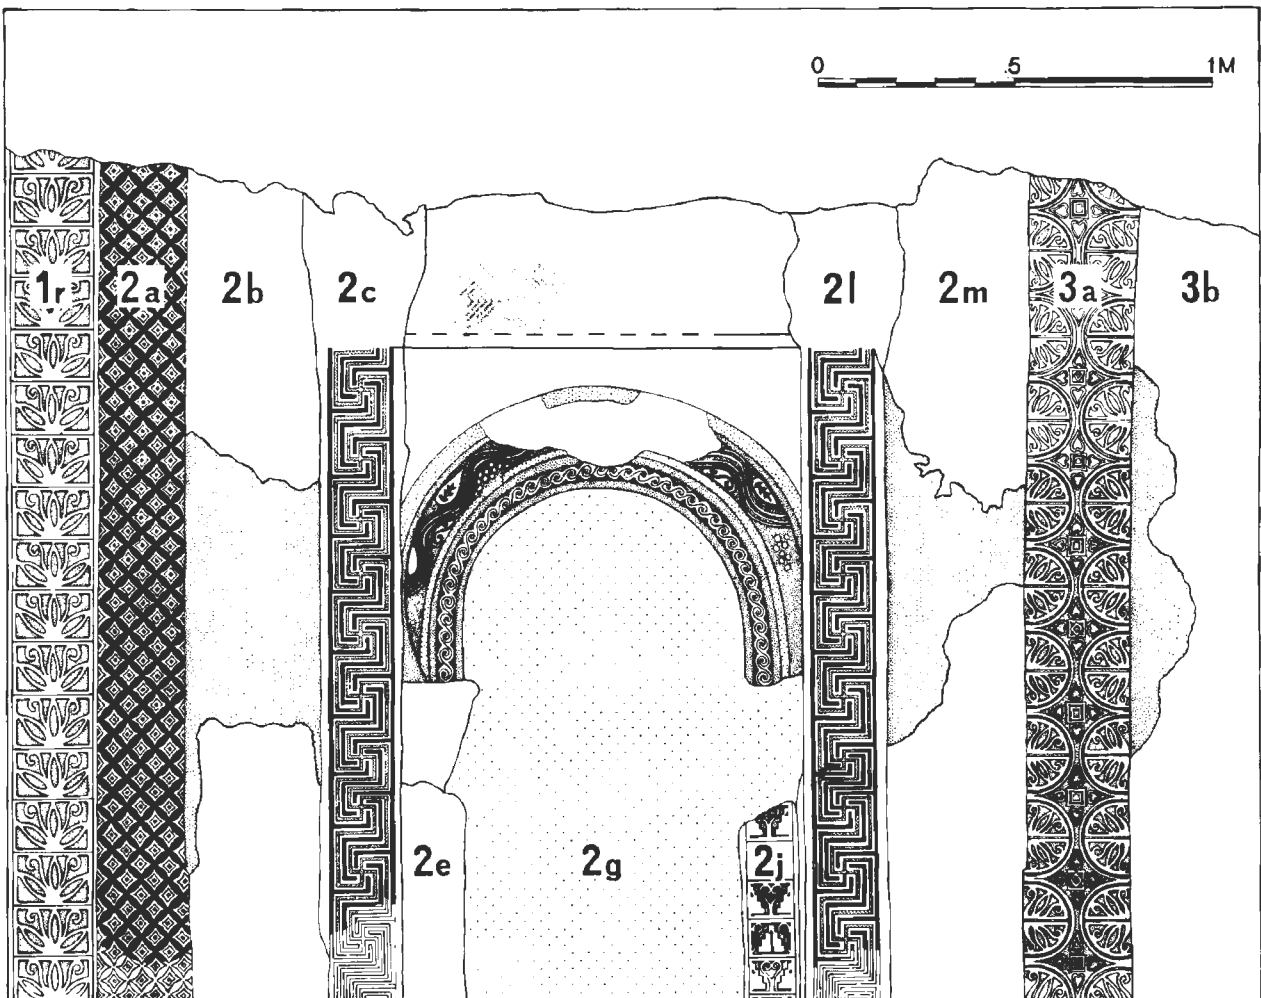
Fig. 4. 1. Area 5, niche 1 elevation; 2. Area 5, niche 2 elevation.

The niches of area 5 reveal some interesting details about the nature of the application of the stuccoes to the walls. As can be seen in the Conservation Report (v. *infra*), both moulding and carving techniques are evident on the site. In the case of niche feature 2a (Fig. 4, no. 2), it was clear that the plasterer was executing the design *in situ*, for the interlocking circle motif has become distorted through the rapid execution of wet plaster (cf. also Pl. XVIc). By contrast, in the case of feature 11 (Pl. VIIc), where the plaster has broken away completely from the wall, it would appear that the panel has been applied from a pre-moulded piece. In the case of both niches (Pls. Va and VIIa), the capitals were applied as separate units, with the result that one of them (2j) has fallen out completely. Cut lines in the plaster reveal that the rough form of the niche was created, and then a bedding for the capital was chopped out and the moulded capital was set into place. In Pls. VIb, VIIa and c the finger marks are a reflection of the way in which the capital was formed: the impressions are the reverse image of marks left on the concave back of the capital while its face was being formed in a mould.

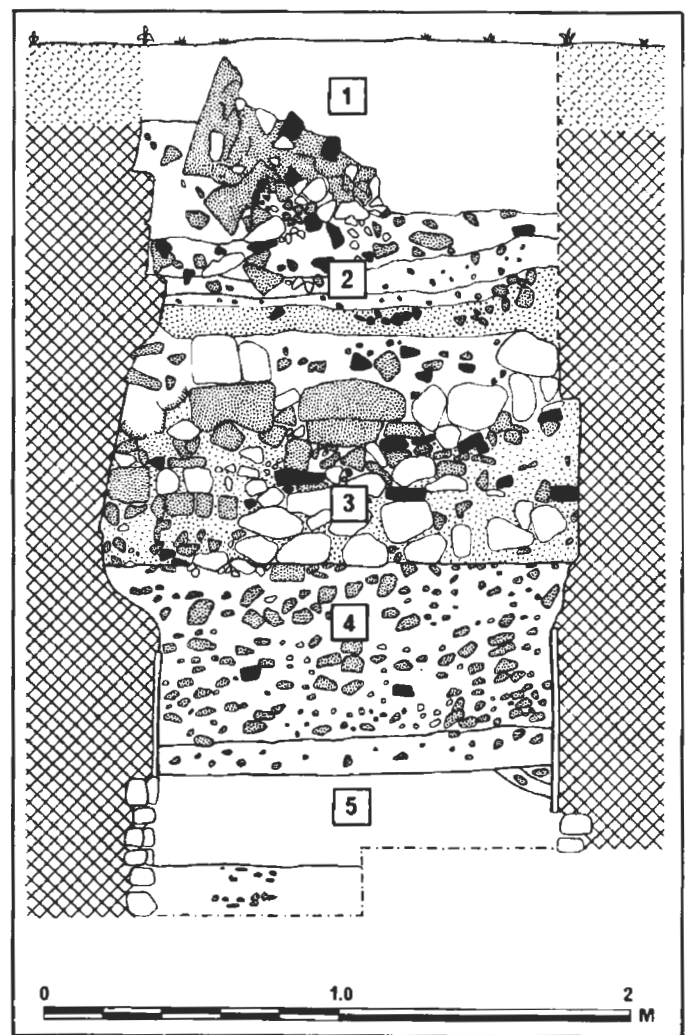
Fig. 5, 1. Area 1, section; 2. Area 2, section; 3. Area 12, section.

the appearance of containing a pit or significant lens of material (cf. area 2 section, Fig. 5, no. 2), but more often than not they have little stratigraphic significance. No floors other than those originally laid have been found. Irregular surfaces have been encountered on top of fallen debris, such as might have occurred on top of the thick band of fine fallen plaster in Pl. IIb. It is hoped that, eventually, the

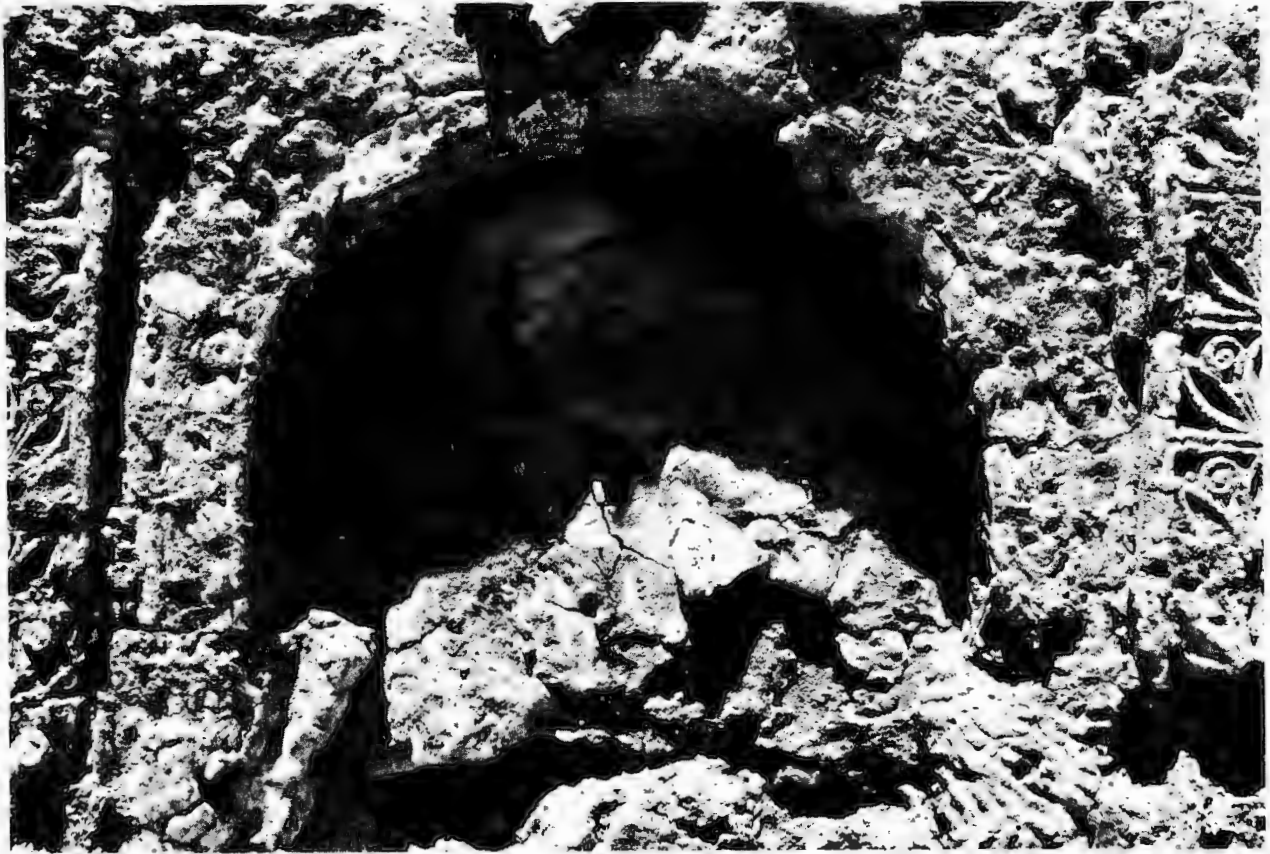
Pl. VIIa. Gach Gumbad, E2S2 Area 5. Niche 1 showing core of moulded capital (right) with reverse image of plasterer's finger marks.

The plasterworkers have also left clear sets of finger impressions, where the parted fingers were drawn through wet plaster to create a series of shallow troughs in the surface (Pl. IXc, and cf. Pl. VIb). It seems evident that these finger impressions generally were intended to assist in keying one plaster surface to another. An example which made this particularly clear was found between a decorated plaster fragment and its structural backing of coarse plaster: when the plasters were separated, the interfaces revealed positive and negative impressions of the finger marks on the respective sides. In the moulding of the engaged figural columns, it appears that the back of the plaster form was made concave as a way of encouraging a better bond when the finished piece was set into its intended position. The concave back of the mould was left deliberately rough, and here again the finger strokes of the workmen have been preserved.

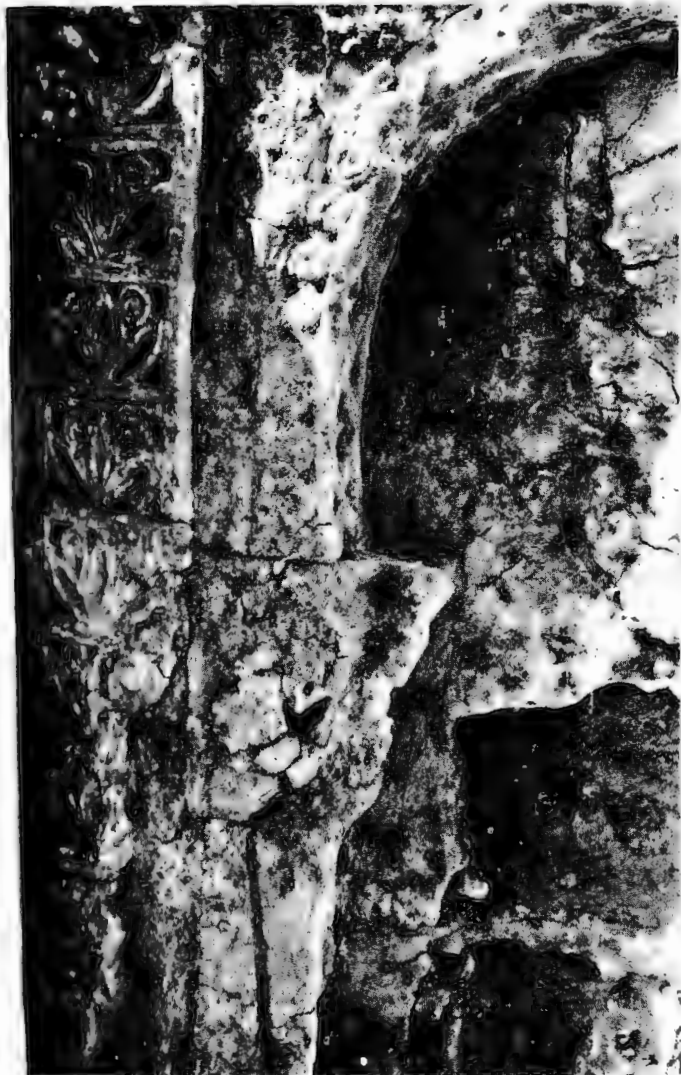
Pl. VIIb. Niche 1 showing reed impression in base plaster of feature 1e. Capital still has vague form of human head in situ.

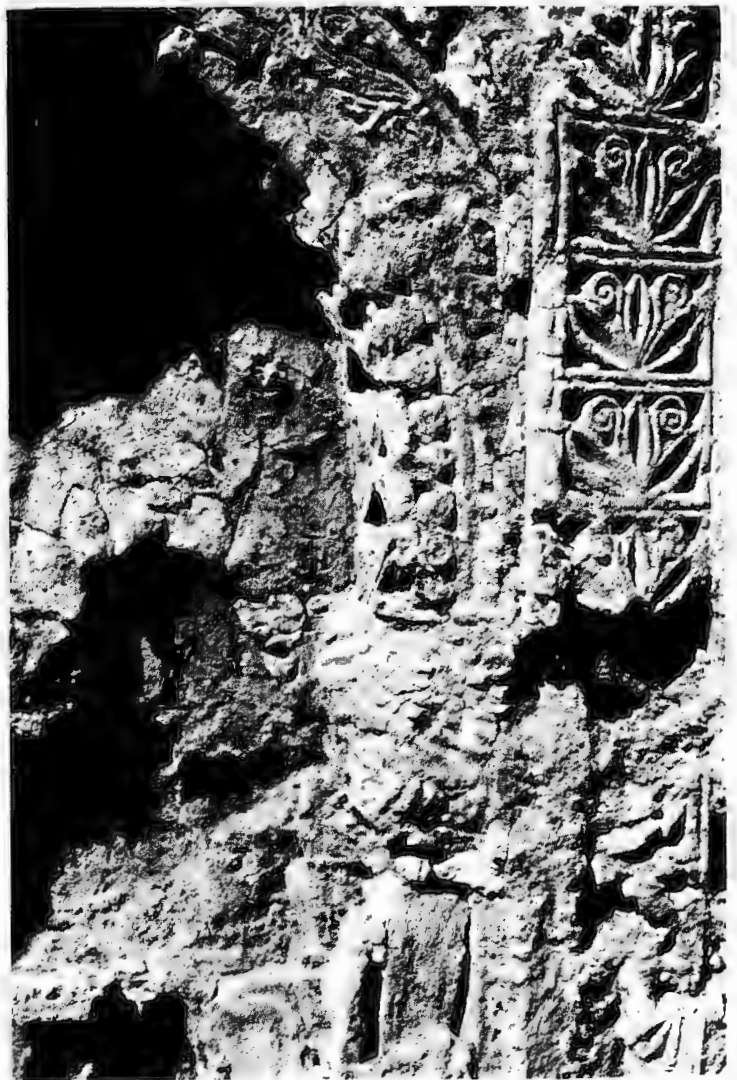
Pl. VIIc. Niche 1 showing moulded panel broken away from feature 1l.

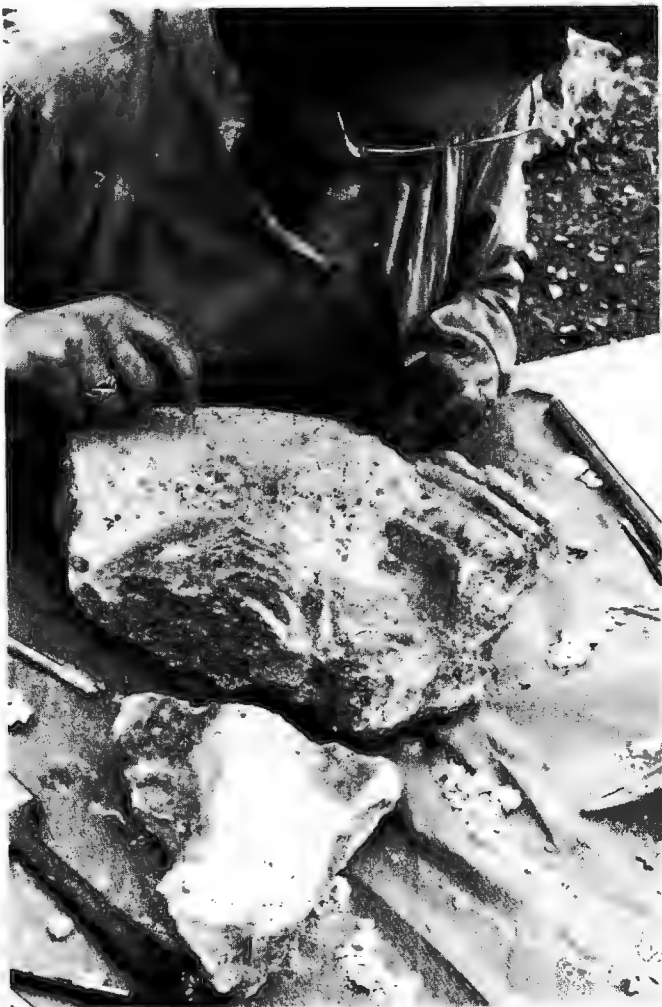
*Pl. VIIIa. Removal of thick overplaster using tack hammer and fine chisel. Object QY78.A51 (Area 201, stratum 3).*

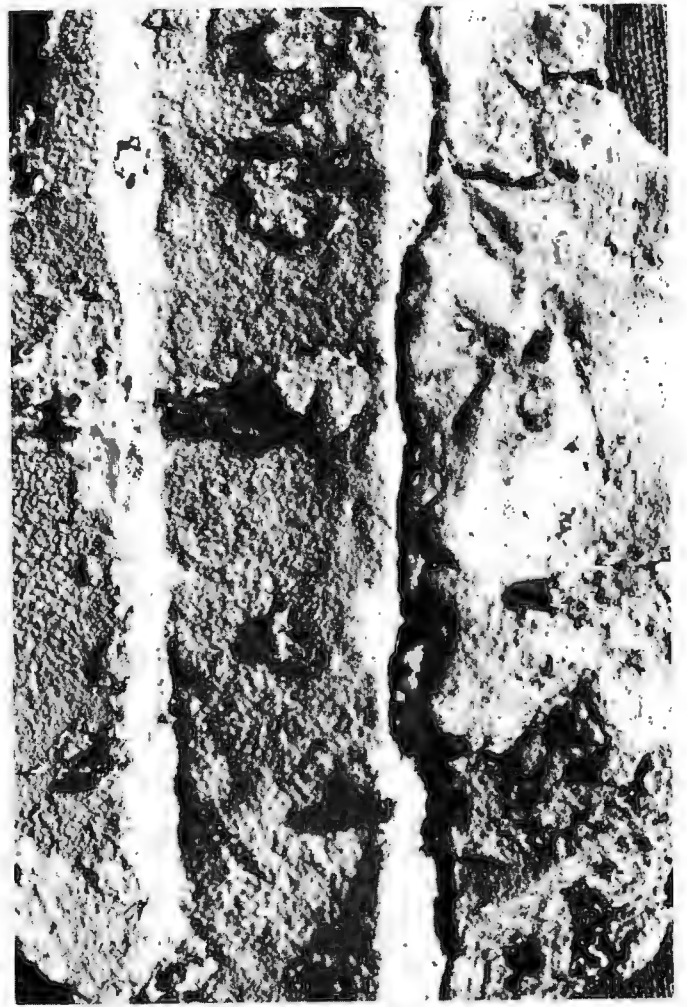
*Pl. VIIIb. Separation of two plaster layers.*

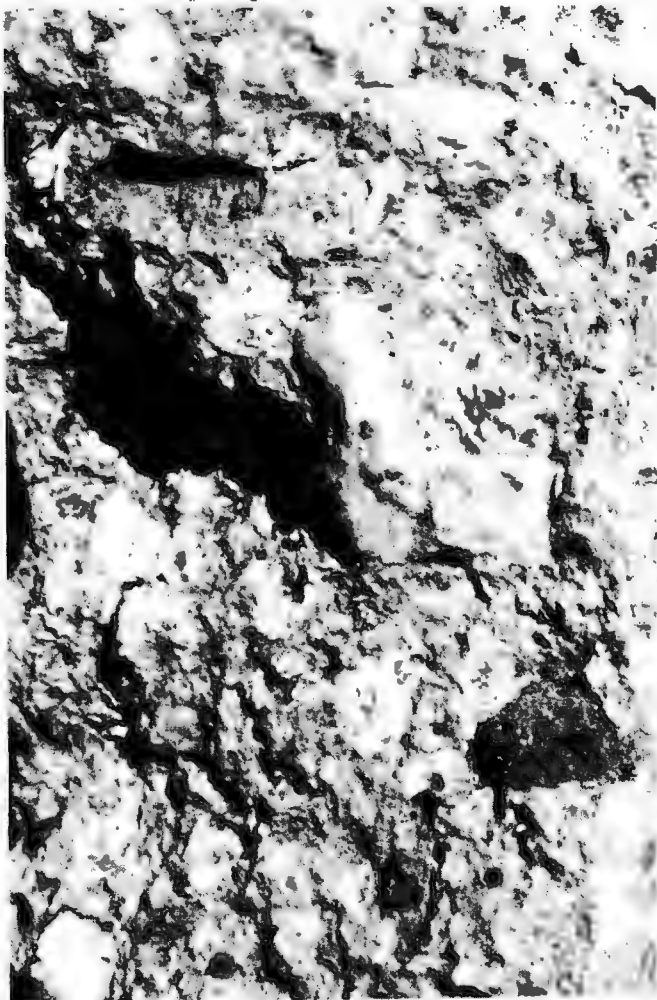
*Pl. VIIIc. Aggregate from a coarse base plaster.*

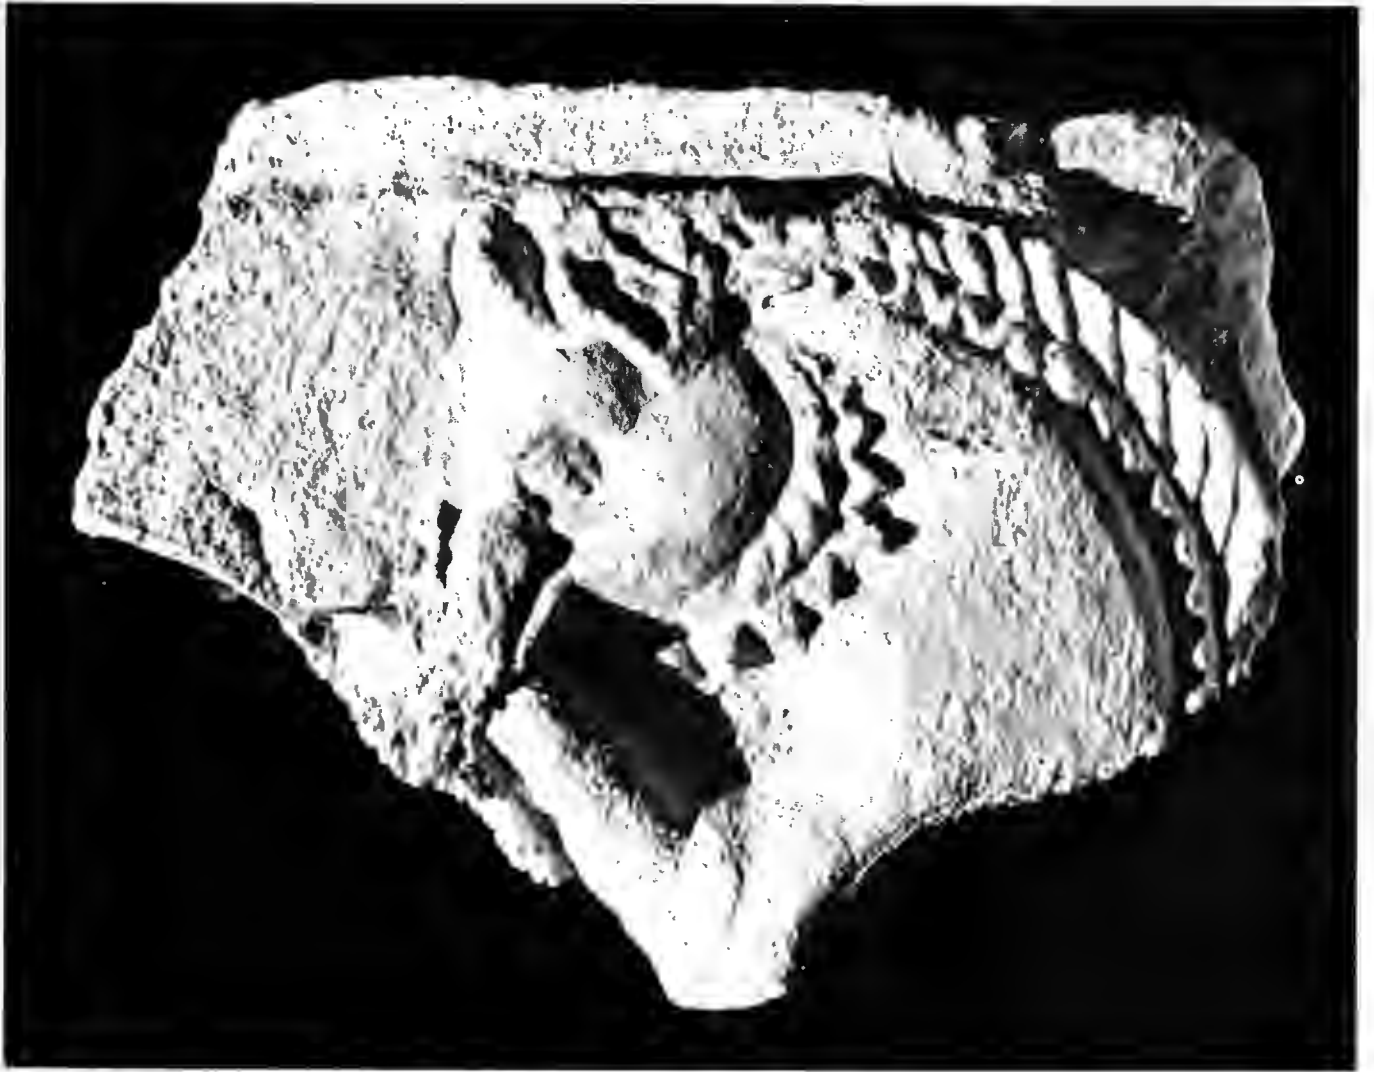
*Pl. XXa. Senmuru-griffon showing areas of fine finishing plaster. QY78.A22 (Area 201, stratum 3)*

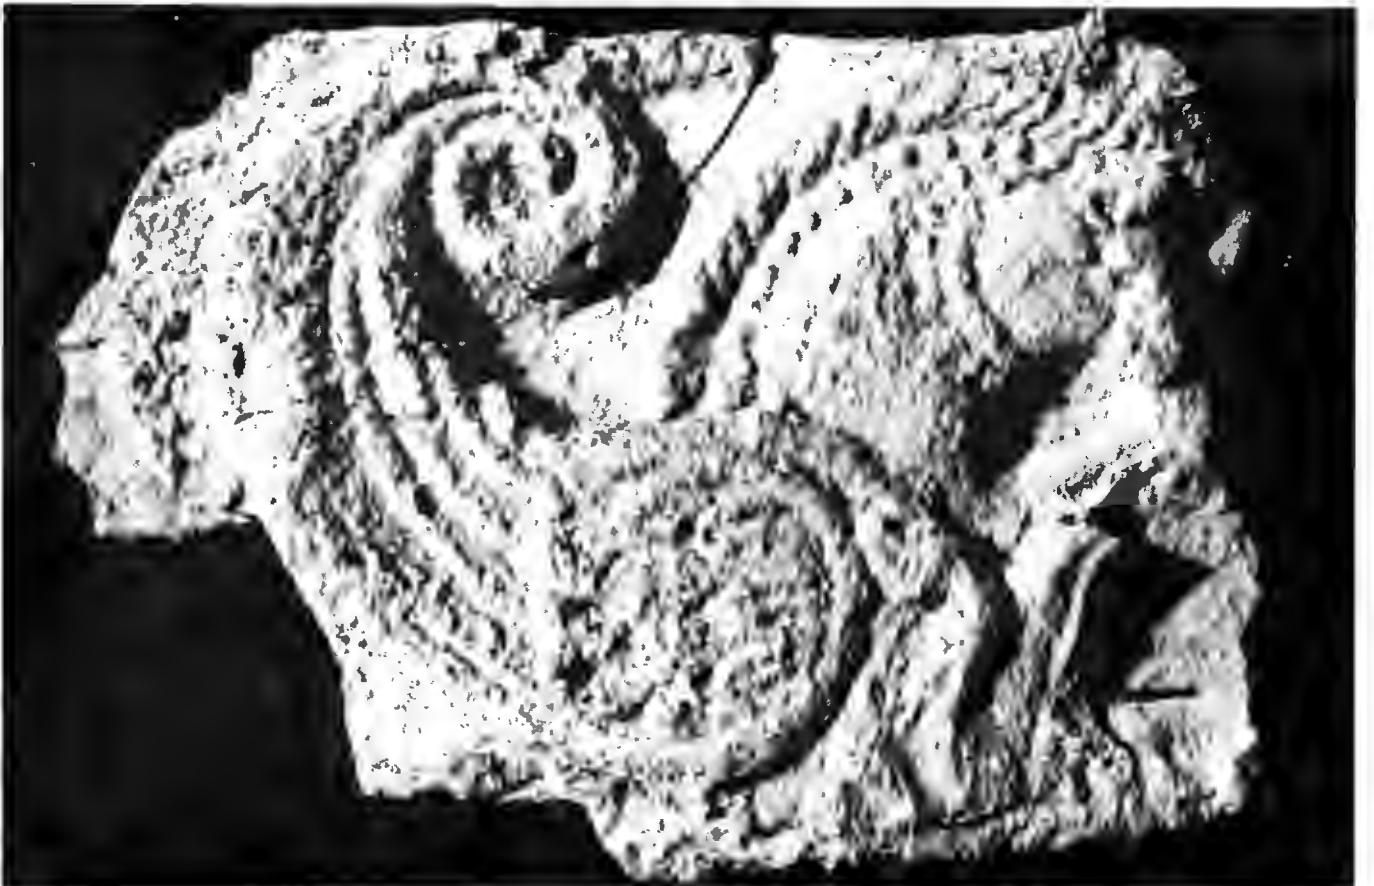
*Pl. XXb. Senmuru-griffon, showing typical condition before removal of salts. QY76.A76 (Area 1, stratum 3).*

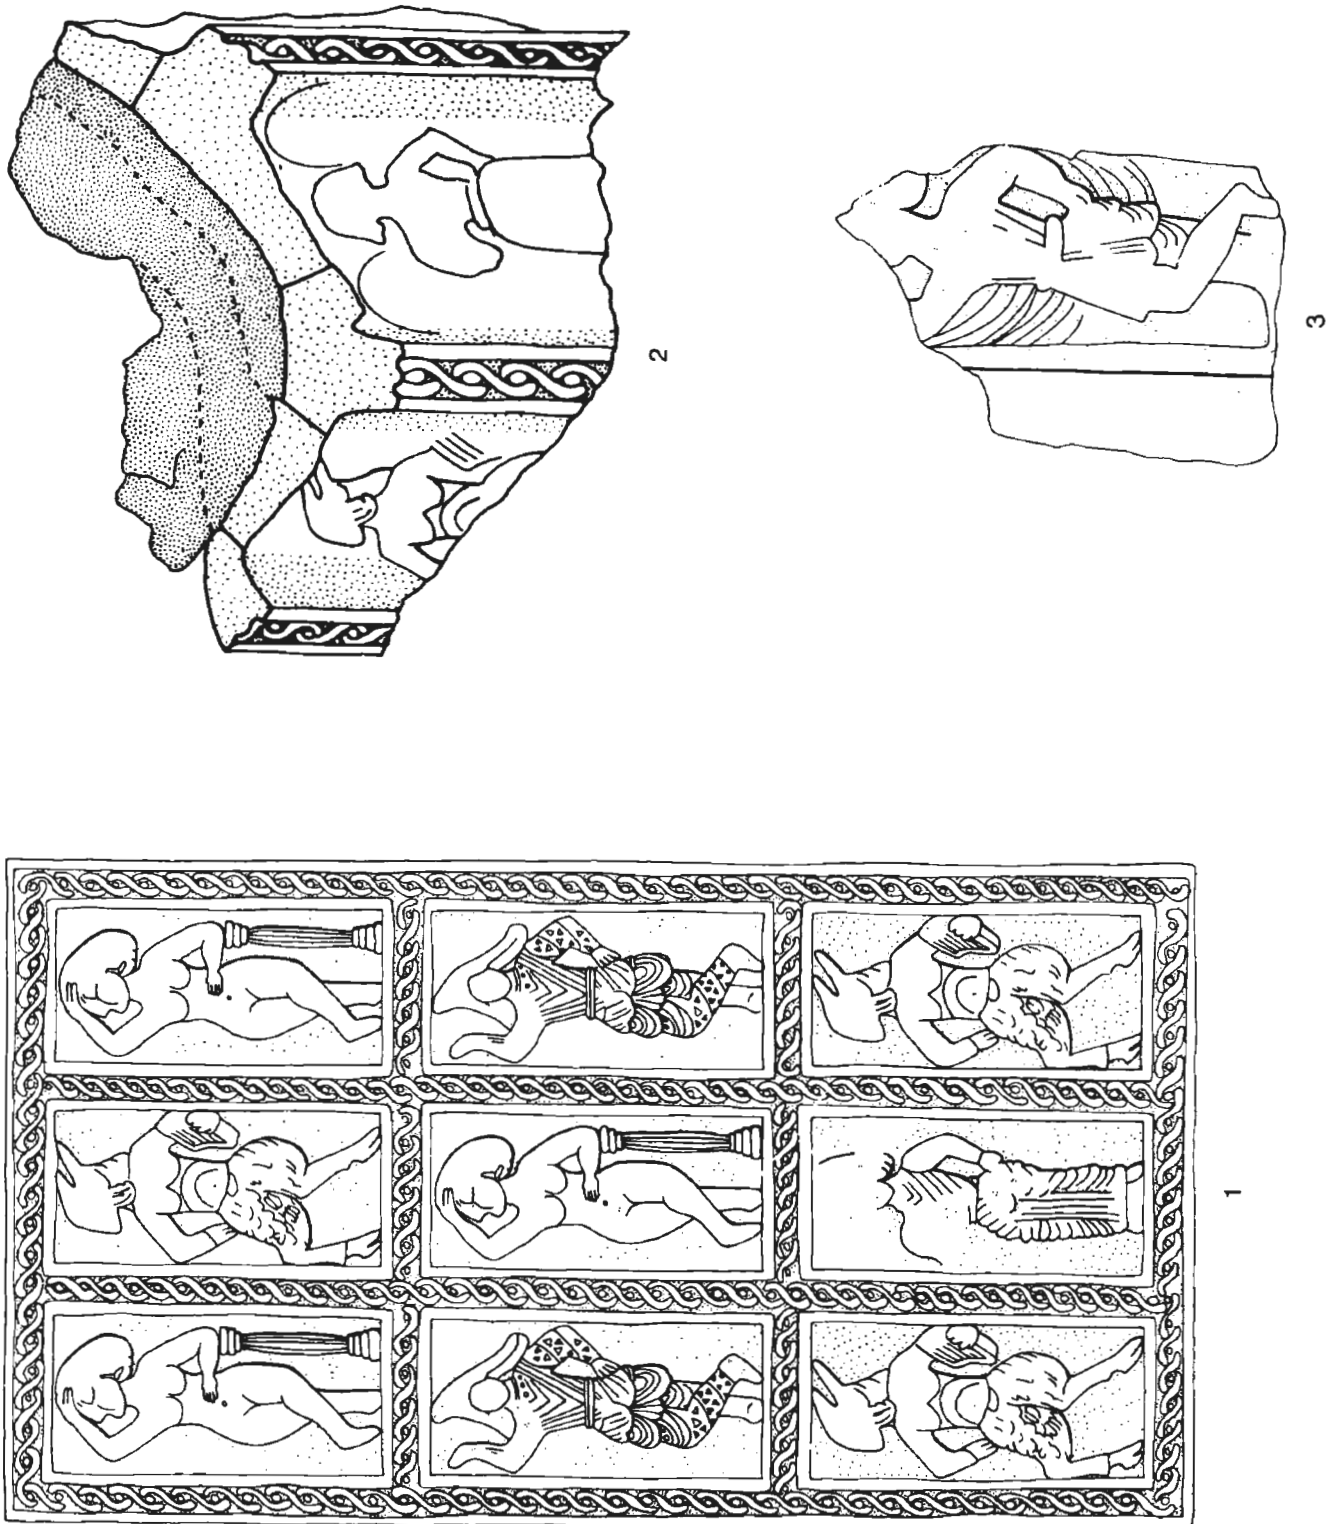
Fig. 25, 1. Conceptual reconstruction of triple-faceted column;  
2. Schematic representation of multi-mould piece

Examination of the fragments showed that the columns were constructed of separately moulded units. The whole array of the vertical mould divisions is visible in the series of darkened separation lines exposed on the top of QY76.A300 (Fig. 25, no. 2). The same sequence of construction was found in all the other column fragments examined, and revealed an unexpected aspect of their manufacture: it was discovered that the figure panels were not moulded as discrete units, but rather that two moulds were necessary to form any one panel. Thus each casting would produce a piece with parts of two figures, separated by a vertical decorative band. This necessitates the figures always being joined in the same sequence (e.g. "Pan"-draped female-"Pan").
